FINAL ACCIDENT INVESTIGATION REPORT

**ACCIDENT OF AIRCRAFT PILATUS PC-6/B2-H4 WITH REGISTRATION
NUMBER PK-SNF
IN THE SEA AREA OF KAKO OROS OF HERAKLION 2 NM EAST OF
HERAKLION INTERNATIONAL AIRPORT ON 15th DECEMBER 2022**

02 / 2025

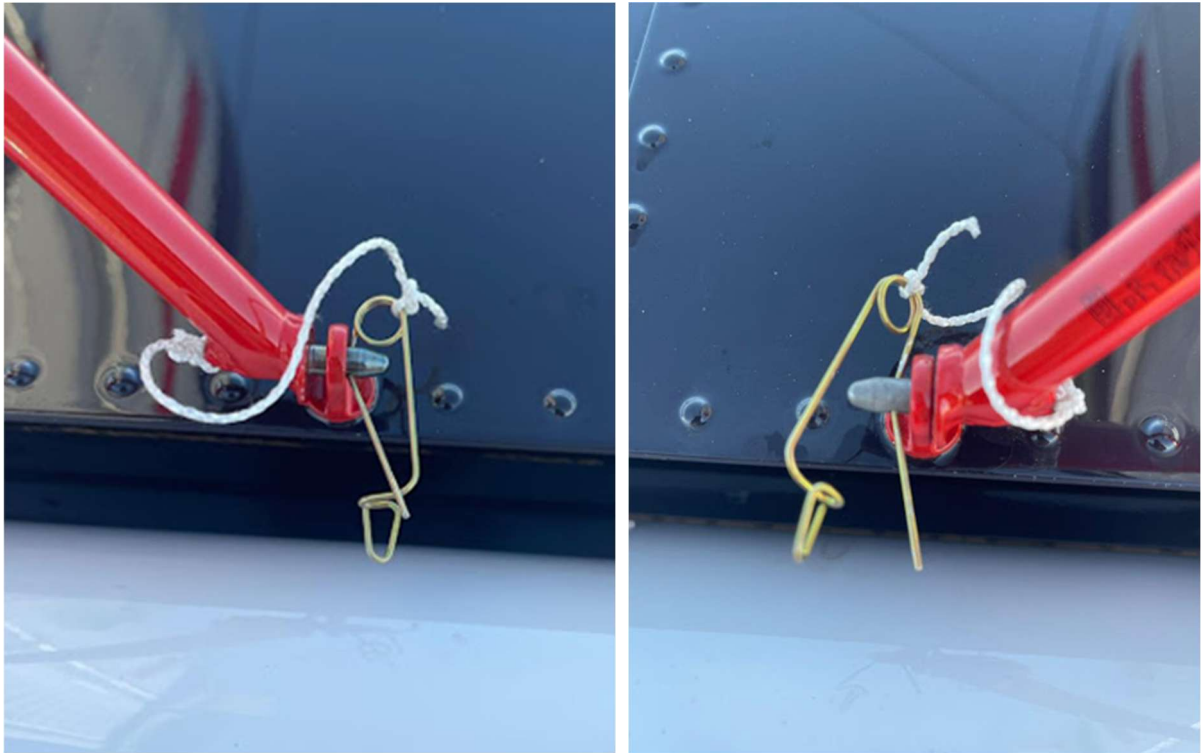
from the vertical/horizontal stabilizer lock, the pins located on the vertical portion of the device had been bent (Fig. 1). The photos were taken by the Pilot before the flight as he stated.

Figure 1 : Safety pins of the vertical/horizontal stabilizer.

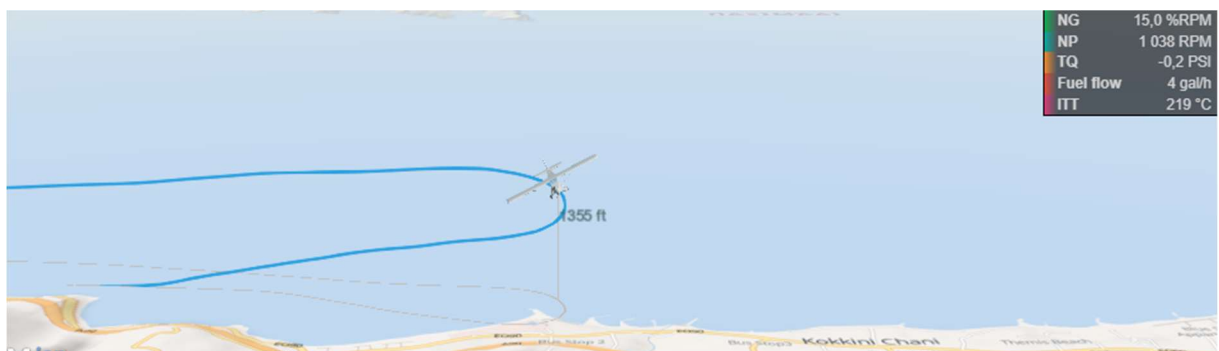
At 09:51:12 the aircraft was at a height of 1355ft (Fig. 5), gas generator speed (NG) was 15.0 % RPM, propeller speed (NP) 1038 RPM, engine torque (TQ) -0.2 psi, fuel flow (FF) 4 gal/h and inter turbine temperature (ITT) 219 °C.

Figure 5: Characteristics of engine performance of the aircraft at a height of 1355 ft.

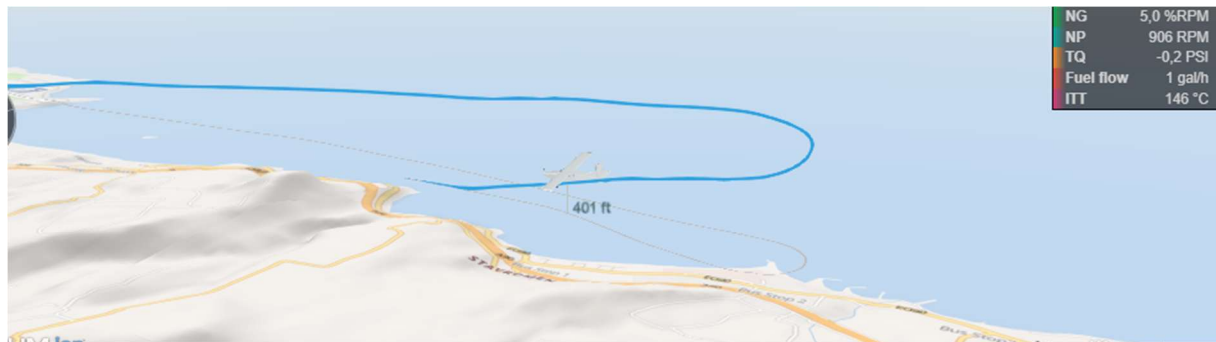
At 09:51:49 approximately 17 sec before the landing the aircraft was at a height of 401 ft (Fig.6), the gas generator speed (NG) was 5.0 % RPM, the propeller speed (NP) 906 RPM, the engine torque (TQ) -0.2 psi, the fuel flow (FF) 1 gal/h and the inter turbine temperature (ITT) 146 °C.

Figure 6: Characteristics of the performance of the engine at a height of 401 ft.

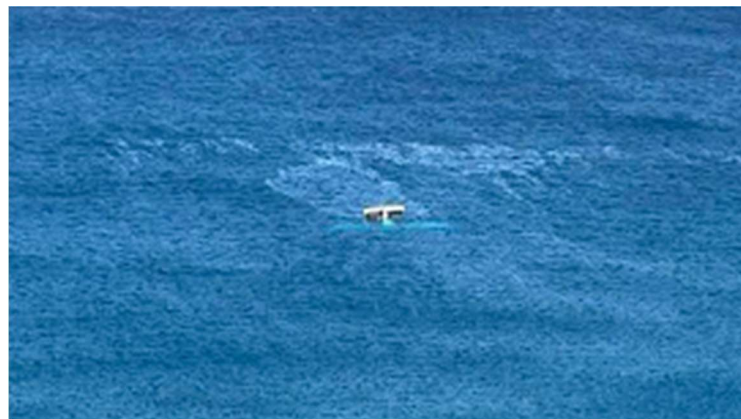
After landing, the aircraft remained on the surface for a few minutes with its front part in the sea and later sank.

Figure 15 Semi-submerged Aircraft

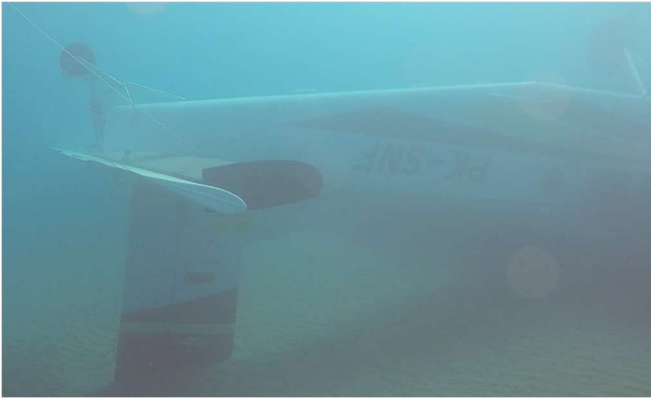
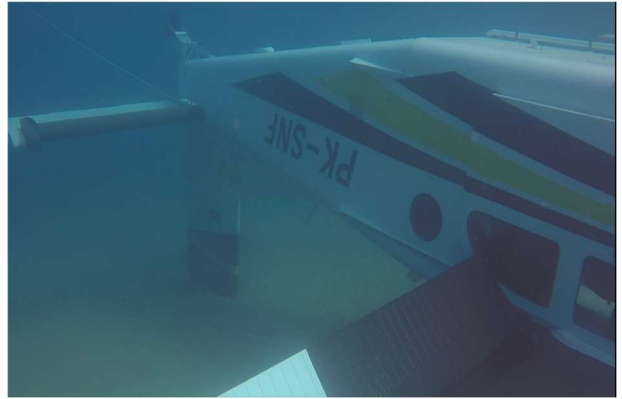
In photographs taken by the divers, the aircraft appears at the bottom of the sea with the upper part resting on it.

Figure 16 The sunken aircraft

Figure 17 The sunken aircraft

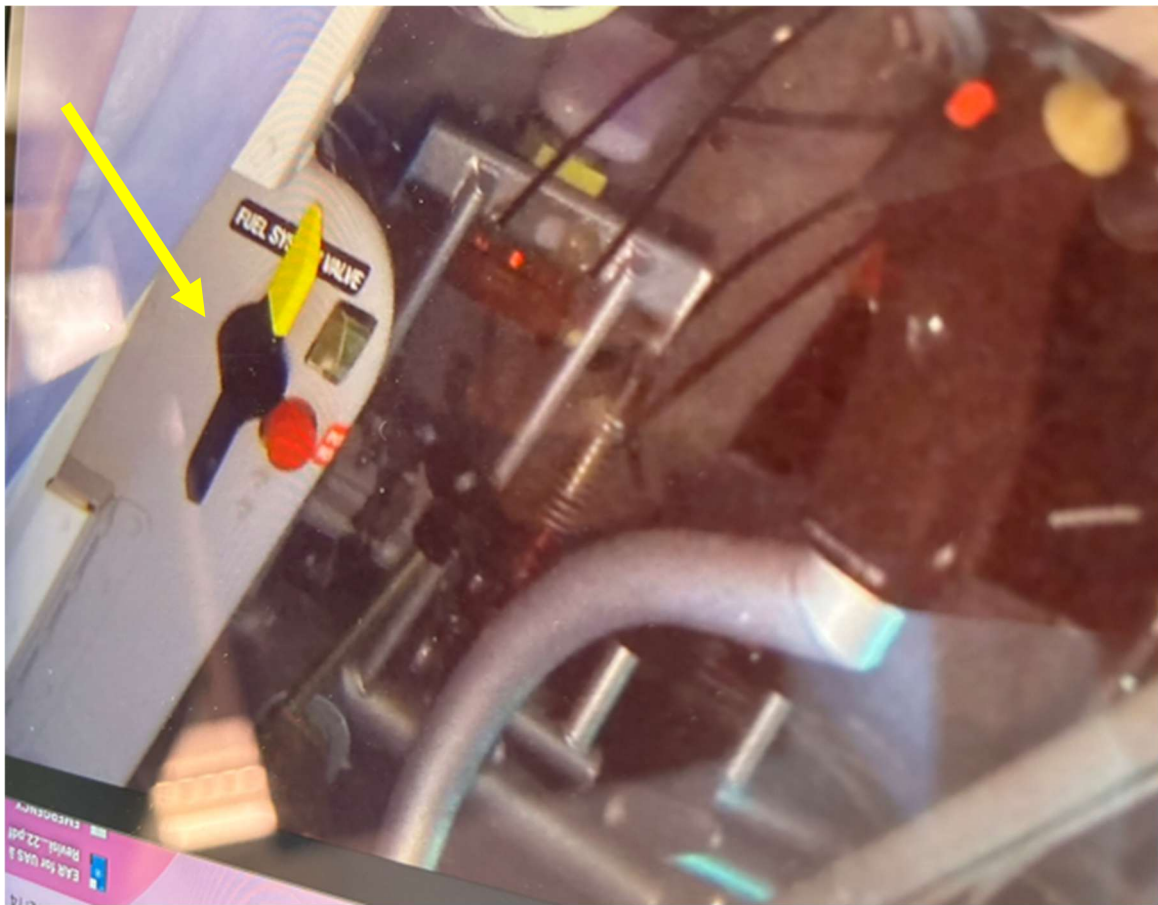
Also, from figure 20 below it appears that the fuel system valve lever was in the closed position “Closed”.

Figure 20 The fuel system valve lever in Closed position

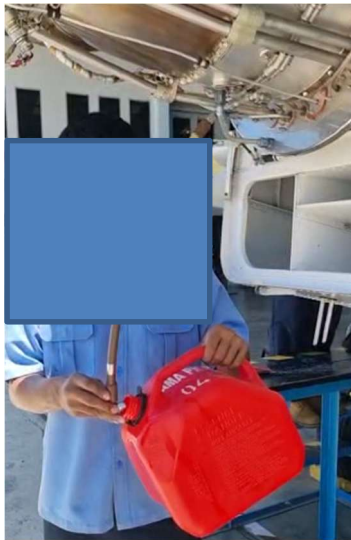
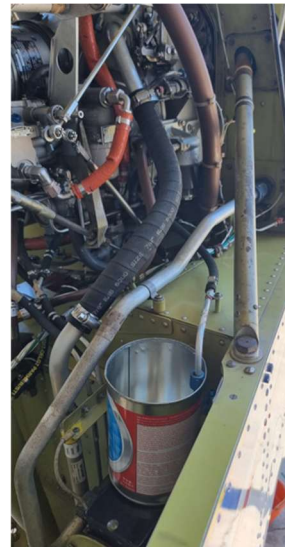
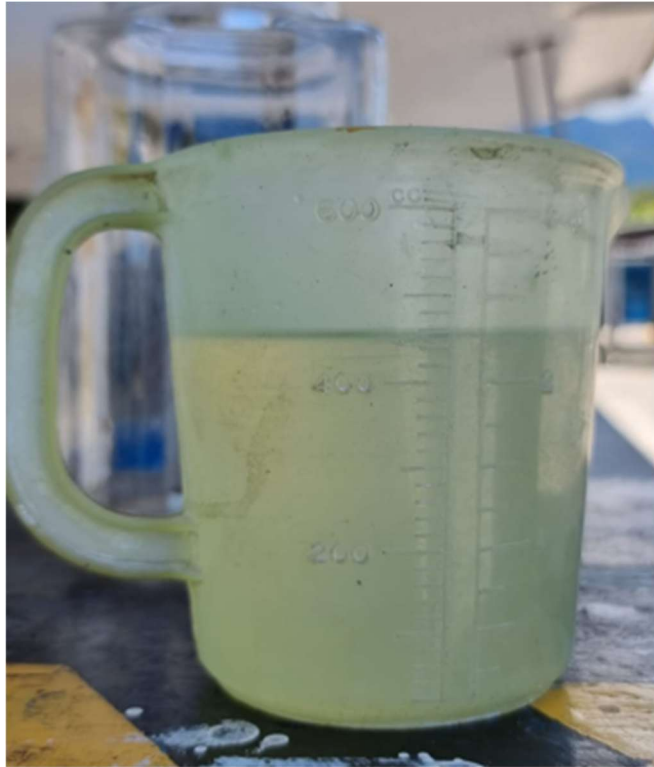
Figure 21 Test to determine the amount of fuel after leaving the shut-off valve in a closed position

Figure 22 Collection of the amount of fuel during the test

The fuel collected had a volume of 460ml.

Figure 23 The amount of fuel collected after the test

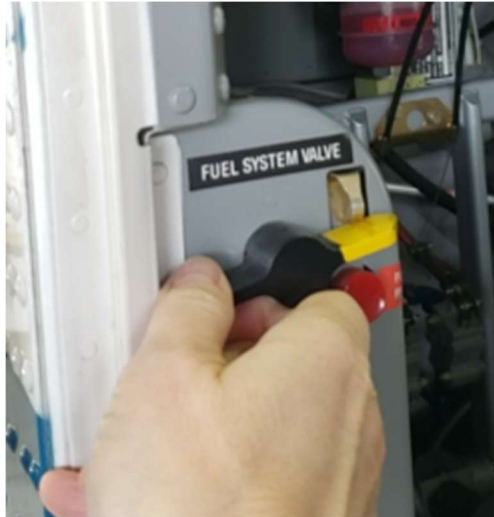
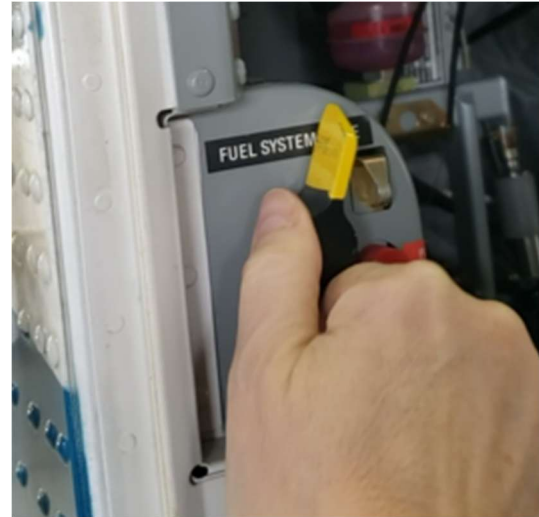
Initially, it was observed that it is possible to turn the fuel system valve upwards (in its closed position), without pressing the red button that isolates the lever locking mechanism. There was only a small resistance, as well as a small noise, without marks or deformation of the mechanism.

Figure 24 Fuel system valve test

Figure 25 Fuel system valve test (continued)

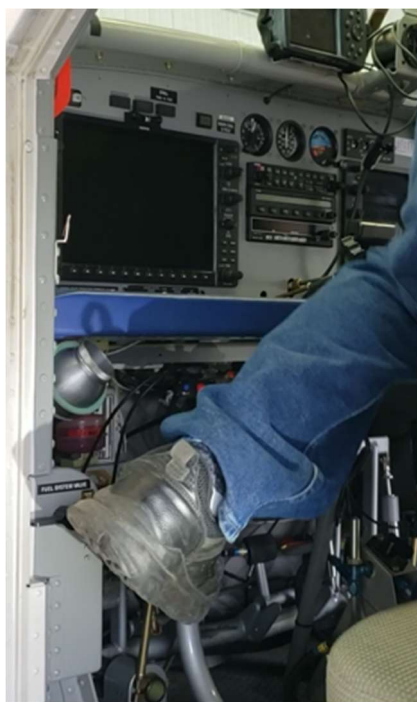
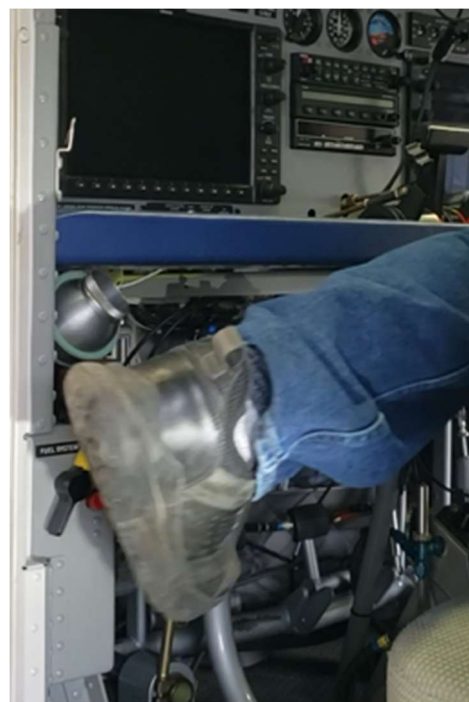
Then there was a simulation of the movement of the Pilot's body in his attempt to close the door. A person (who is 180 cm tall, roughly the same as the Pilot) was asked to sit in the left seat and close the rear right door. Initially, the person could not reach the door without unfastening the seat belt. He was asked to unfasten the seat belt and try again. As the person stood up and stretched his body to close the door, he lifted his foot and moved the fuel system valve towards the close position. He tried several times and managed to close the fuel system valve with his foot several times with relative ease.

Figure 26 Simulation of Operator body movement, closing of the right door of the cabin

Figure 27 Simulation of Operator body movement, cab right door closing (continued)

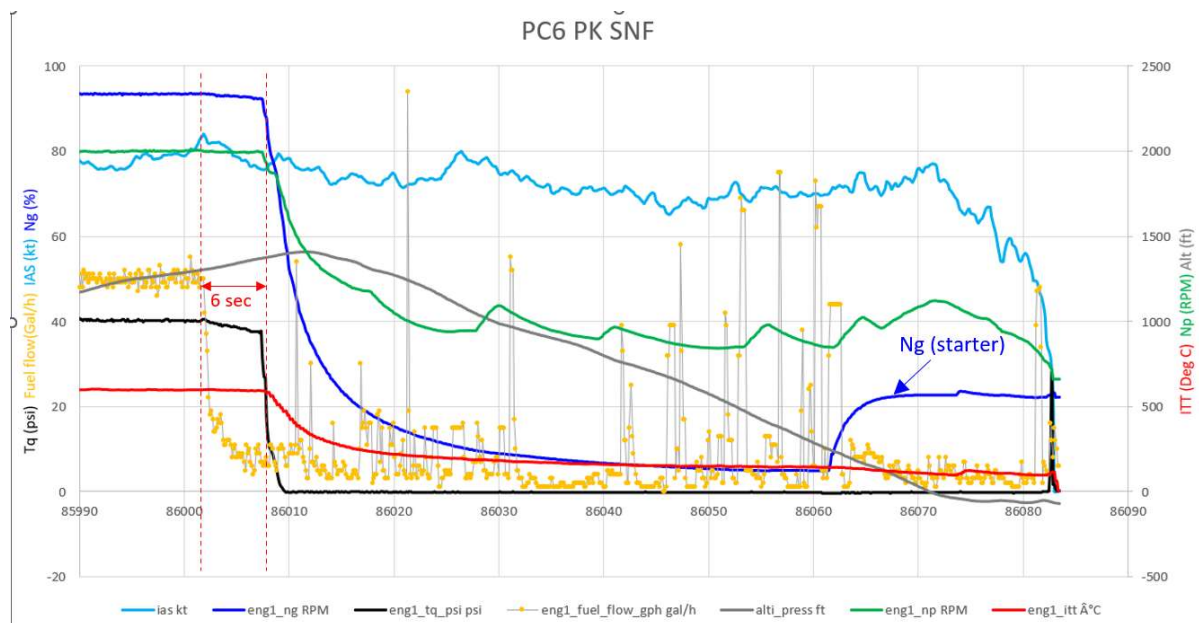
The graph 1 below shows some aircraft and engine parameters taken from the APIBOX recording system from 07:50:41h to 07:52:15h inclusive. There is a delay of about 6 sec between the drop in fuel flow and the drop in engine parameters Ng, ITT, Tq & Np. Considering that the Operator inadvertently closed the fuel shut-off valve, the above-mentioned delay of 6 seconds may be due to the fuel present in the fuel system after the shut-off valve and up to the combustion chamber.

Graph 1 Aircraft and engine parameters taken from the APIBOX recording system
