**HELLENIC AIR AND RAIL SAFETY
INVESTIGATION AUTHORITY
H.A.R.S.I.A**

**ACCIDENT INVESTIGATION REPORT
OF CESSNA R.182 AIRCRAFT WITH REGISTRATION MARKS
4X-CHZ IN THE SEA AREA OF PYTHAGORION, SAMOS**

ACCIDENT INVESTIGATION REPORT

**Cessna R.182 aircraft with registration marks 4X-CHZ on September 13, 2021 in
the Sea Area of Pythagorion Samos**

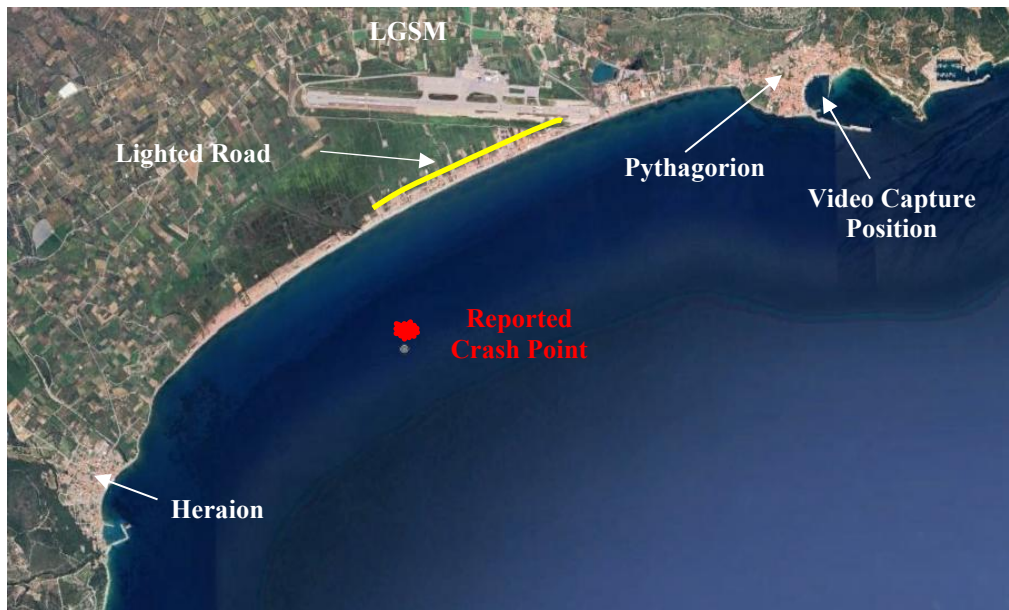
Picture 1: The Accident Site.

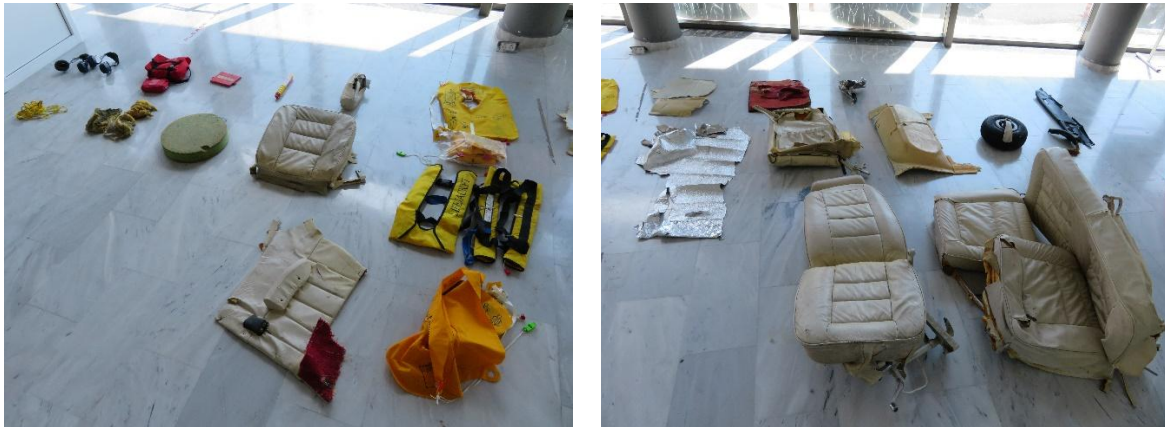
At 22:10 h, the Underwater Missions Unit carried out an underwater search at the point 37° 40' 24" S and 026° 55' 22" E and around it, aiming to find the a/c as well as trapped persons, with negative results. The debris found during the initial investigation at the accident site, were recovered by floating vessels and transported to a hangar for safekeeping (Photos 1, 2).

Photo 1, Photo 2: The a/c recovered wreckage after the initial accident site search.

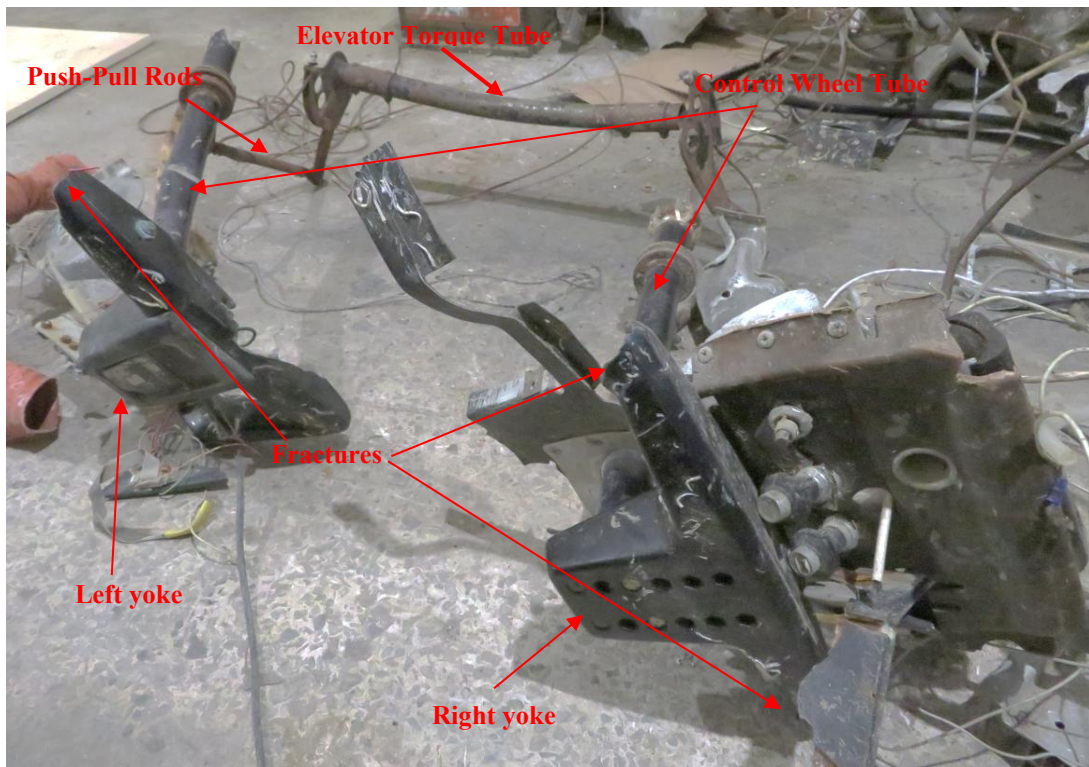
- The left yoke was fractured on its right side, Photo 3. The right hand yoke was fractured in its left and right side, Anx. 5.11, Photo 15.
- The cockpit instrument panel was broken in the center section and outboard of the right yoke.

From the macroscopic examination it was observed that the two yokes were in the left roll position, Photo. 3. The mounting points of the two push-pull rods on the two control wheel tubes have been twisted to the right (Anx. 5.11, Photos 19, 20), while the elevator torque tube was bent, consistent with the compression load applied to the tube, as a result of the impact, Photo 3.

Photo 3: Controls arrangement reconstruction.

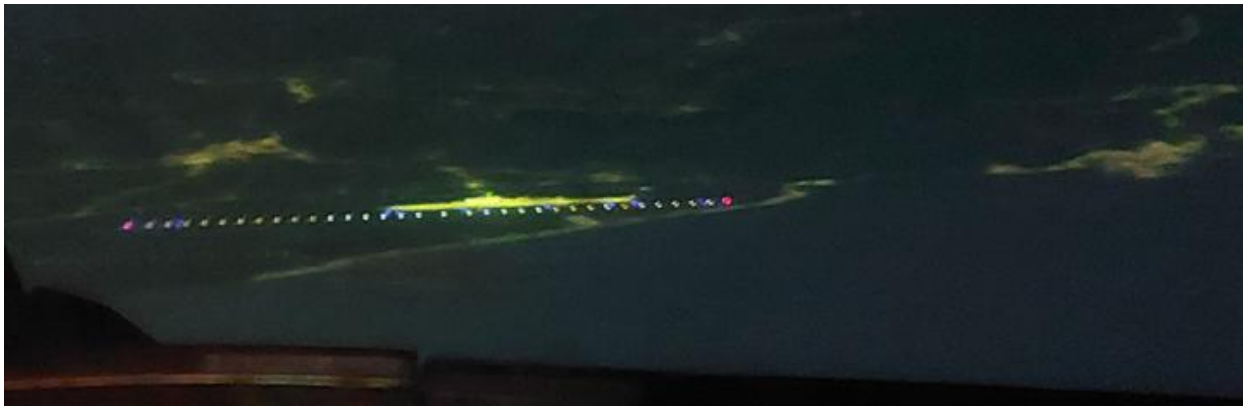
From the visual reconnaissance, it was observed that at all four different heights, were visible: the runway edge lights (as the height was reduced, the runway edge lights became less distinct compared to the apron flood lights), the red lights at the end of runways 09 and 27, the apron flood lights and the control tower beacon green light.

Photo 4: The LGSM lights visible at 2.8 NM from the SAM VOR/DME at an altitude of 2770 ft in the flight simulator.

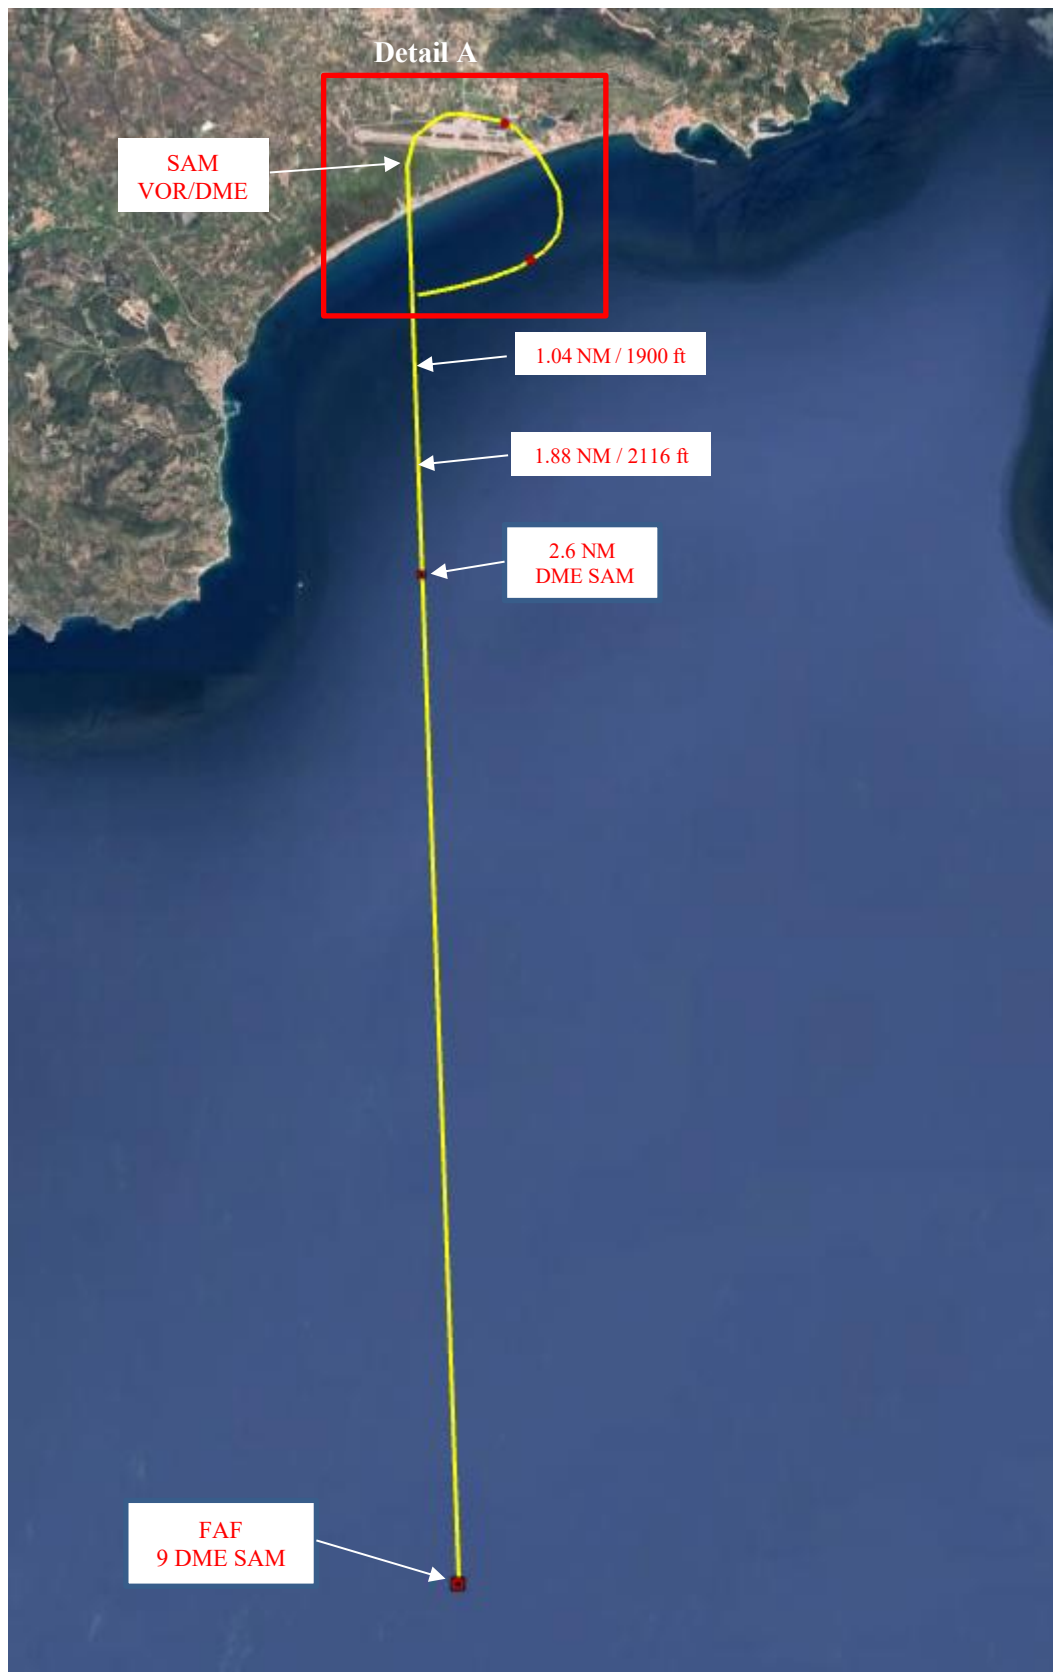
Fig.: 3: A/C estimated track after FAF (Final Approach Fix).

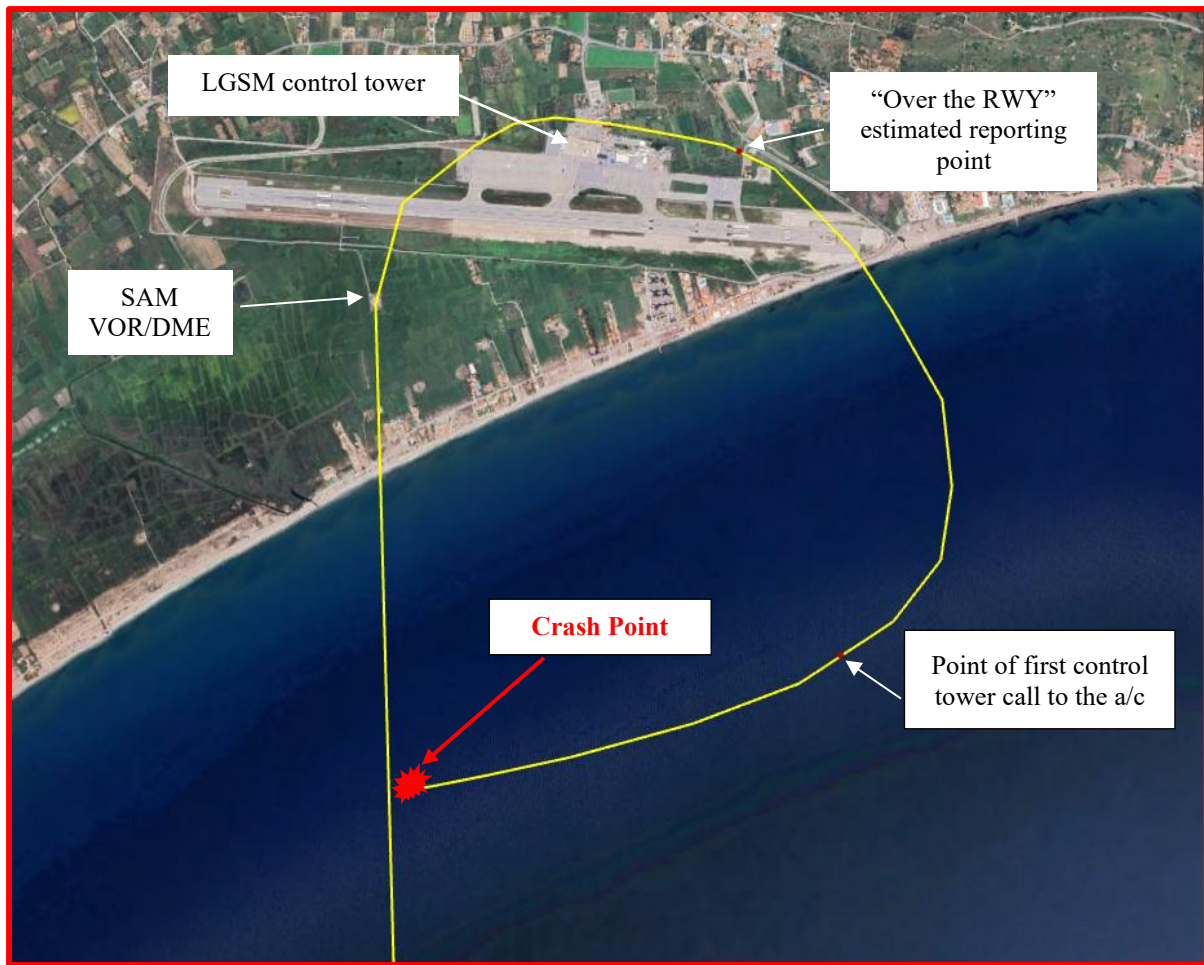
Fig.: 4: Detail A, estimated a/c track based on video footage, after SAM VOR/DME until its crash.

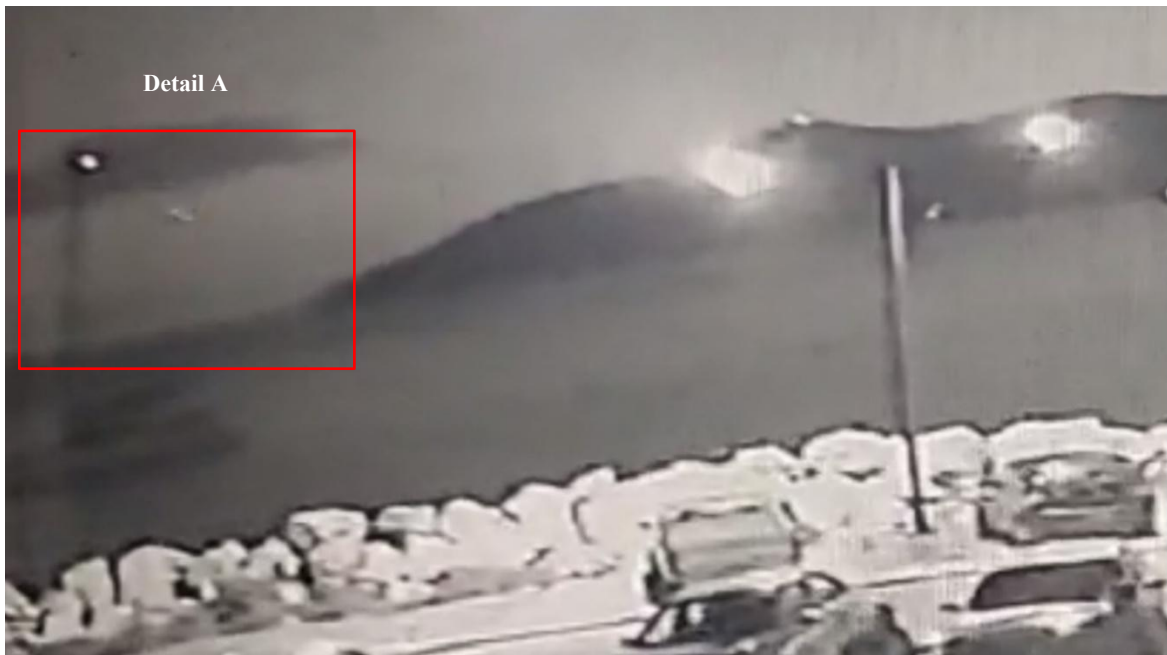
Photo 5: The a/c as captured on the 29th s of video footage, before turning right to enter the south downwind leg.

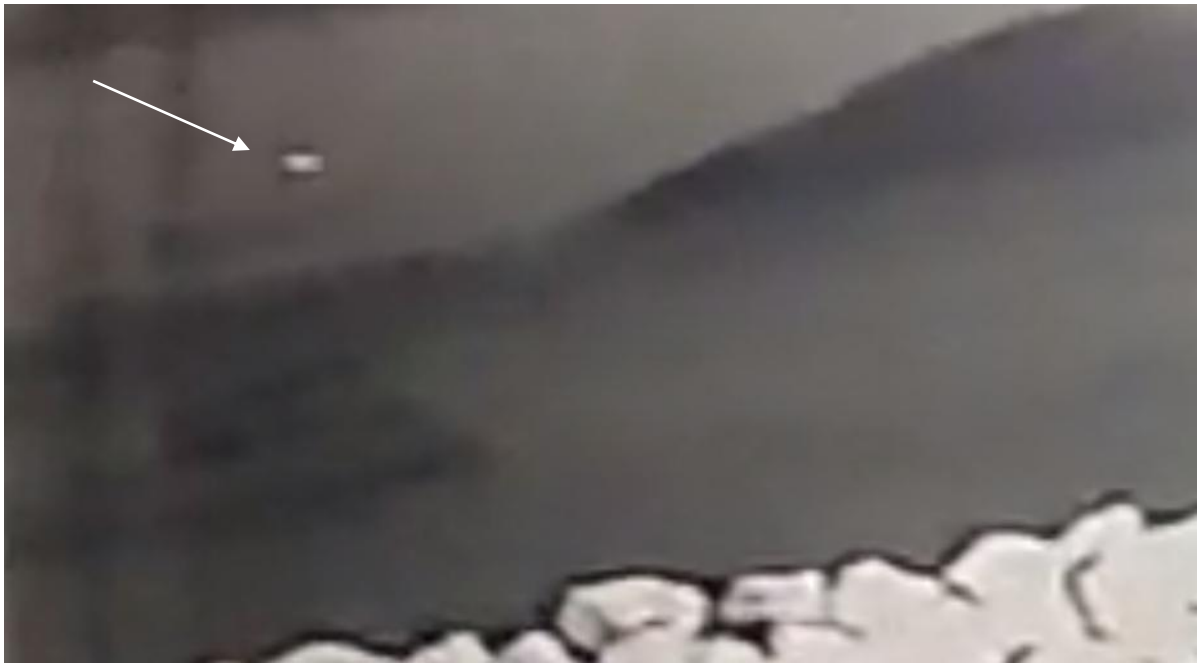
Photo 7: The a/c on the 31st s of video footage during its approximately 90° bank angle right turn.

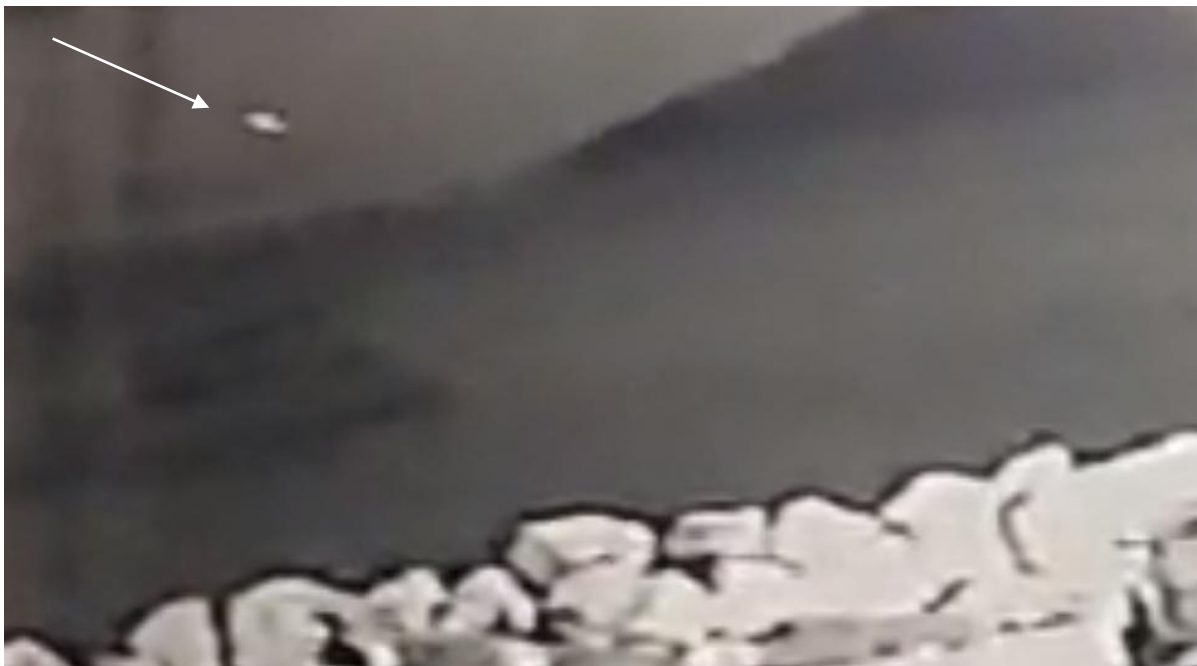
Photo 8: The a/c on the 31st s of video footage during its approximately 90° bank angle right turn and its negative pitch angle.

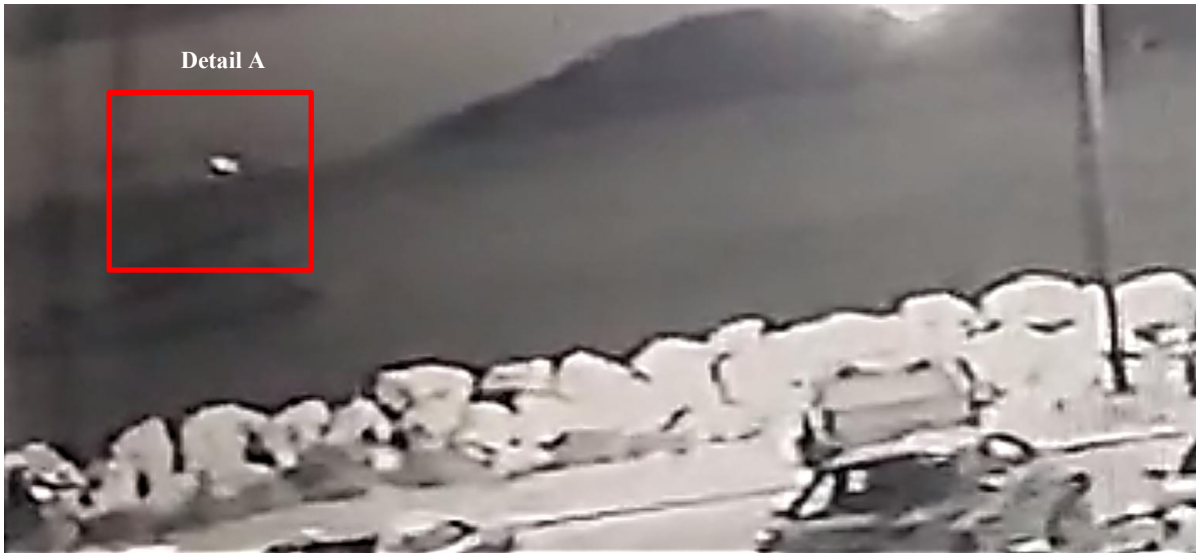
Photo 9: A/C screenshot during the 33rd s of video footage, 1 s prior to its crash.

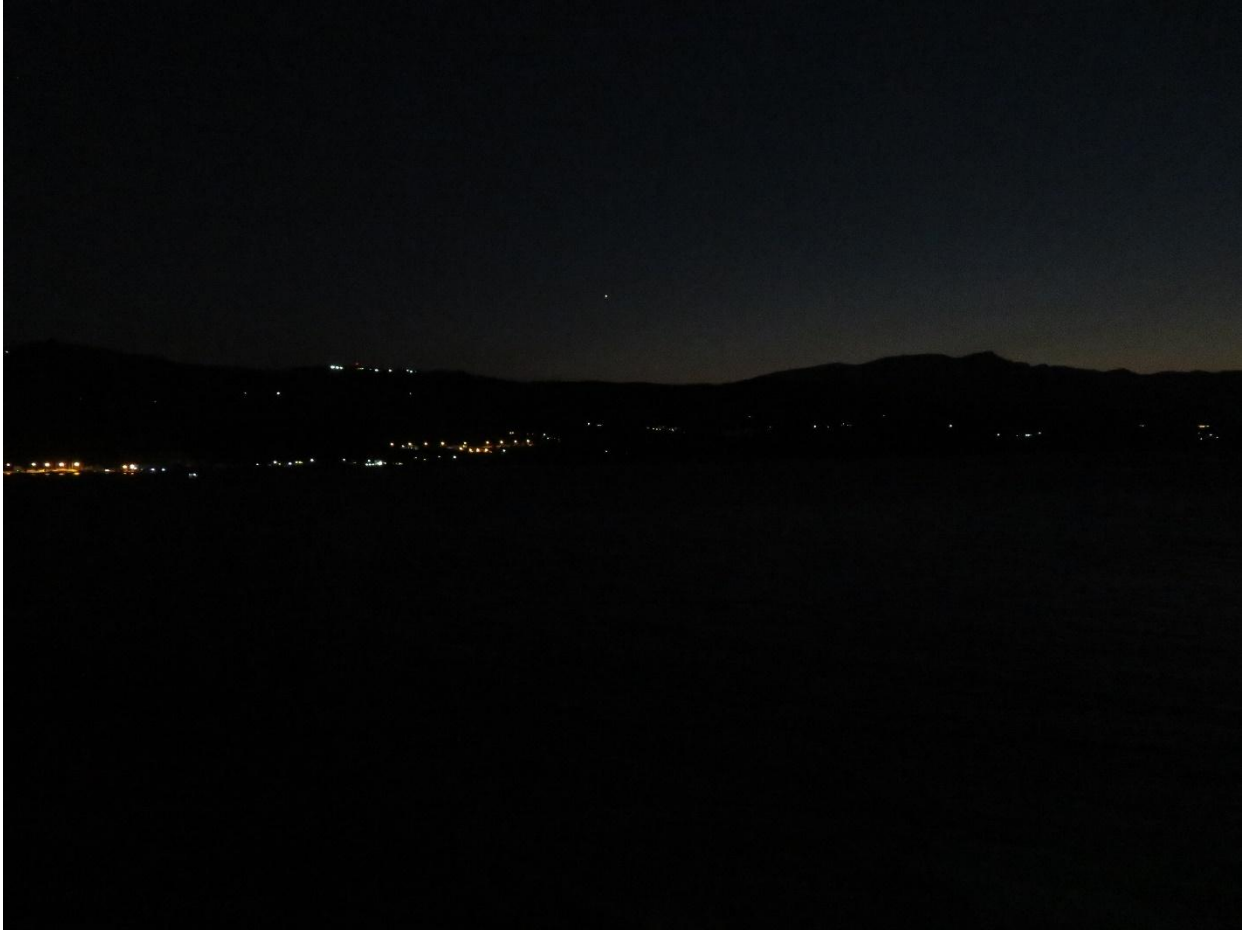
After the a/c crash into the sea at approximately 17:04:12 h in night conditions (Anx. 5.9, Photo 11), a nearby fishing vessel went to the point of impact and its Captain informed the coast guard about the a/c crash, at a distance of five stages south of the airport at a estimated coordinates of 37° 40' 22" N and 26° 54' 30" E.

Photo 11: The ambient lighting conditions at the time of the accident.
The photo was captured on 2021-09-16, 20:05 h local, in a West-southwest direction.
Sunset: 19:19 h LT.

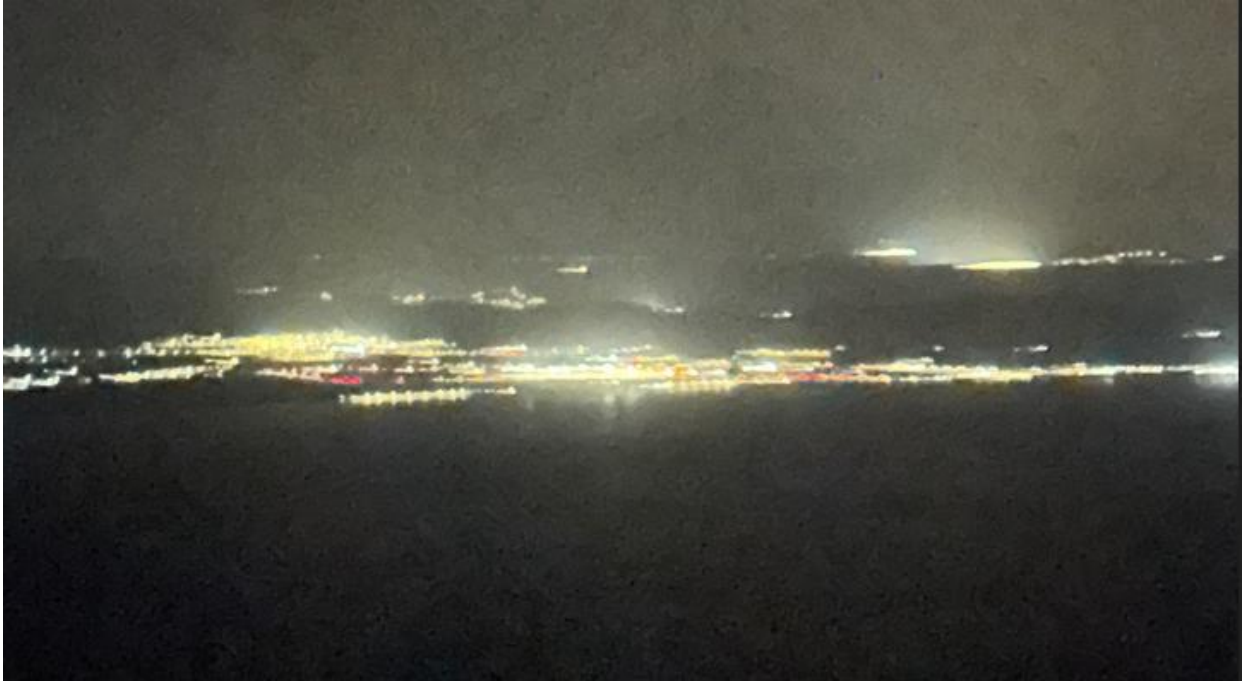
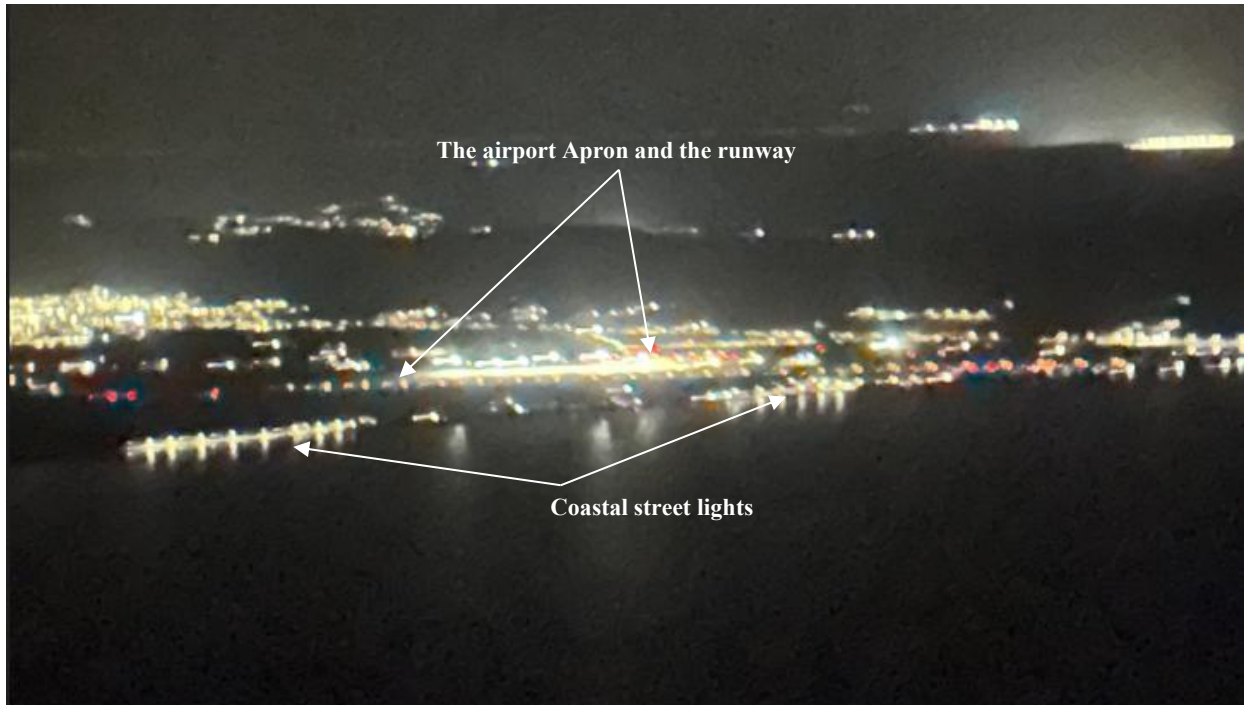
In Anx. 5.10, Photo 12 and Photo 13, Samos airport is depicted in a night flight environment.

From Photos 12 and 13 of Anx. 5.10, it can be observed that the illumination of the coastal lighted road was not visible along its entire length, which reduces the likelihood that the pilot perceived the visible lighted coastal road as the airport runway.

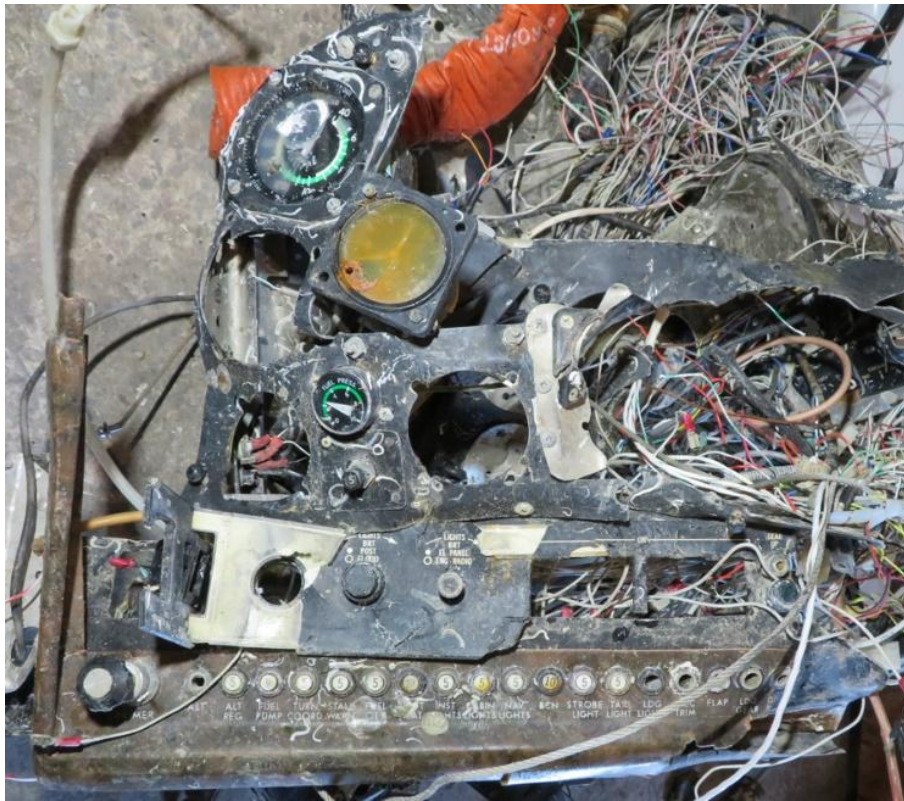
Photo 14: Part of recovered left Instrument panel.

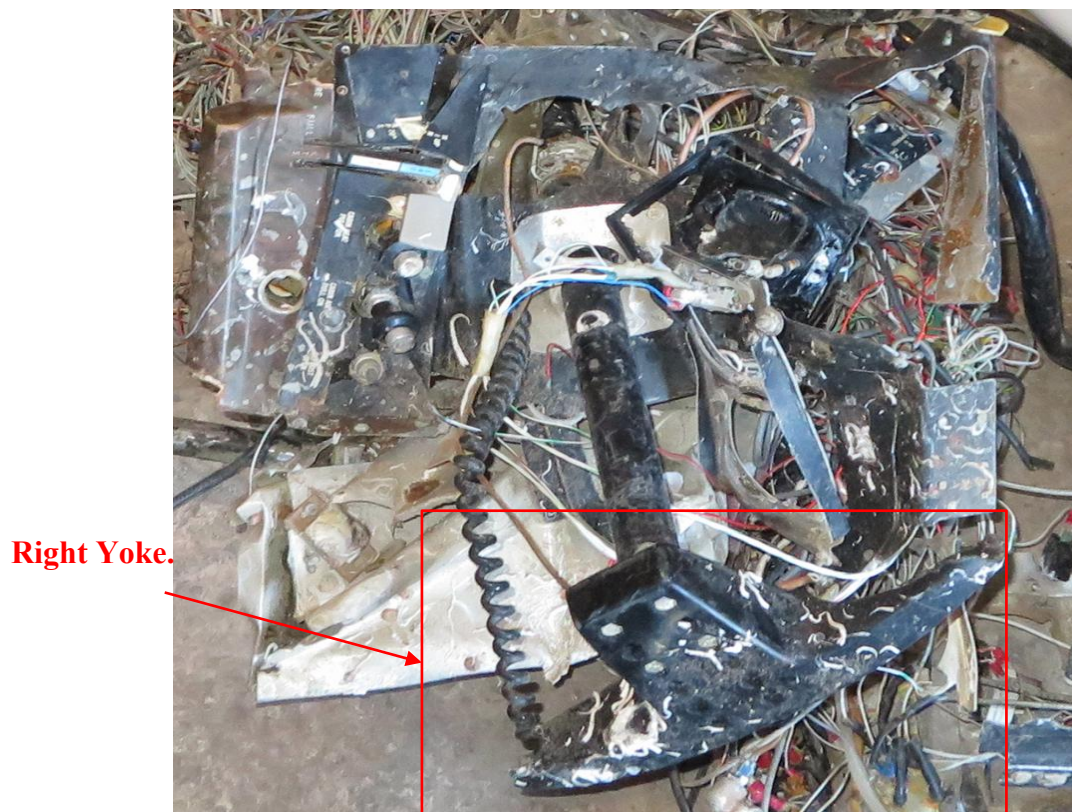
Photo 15: Part of recovered right Instrument panel.

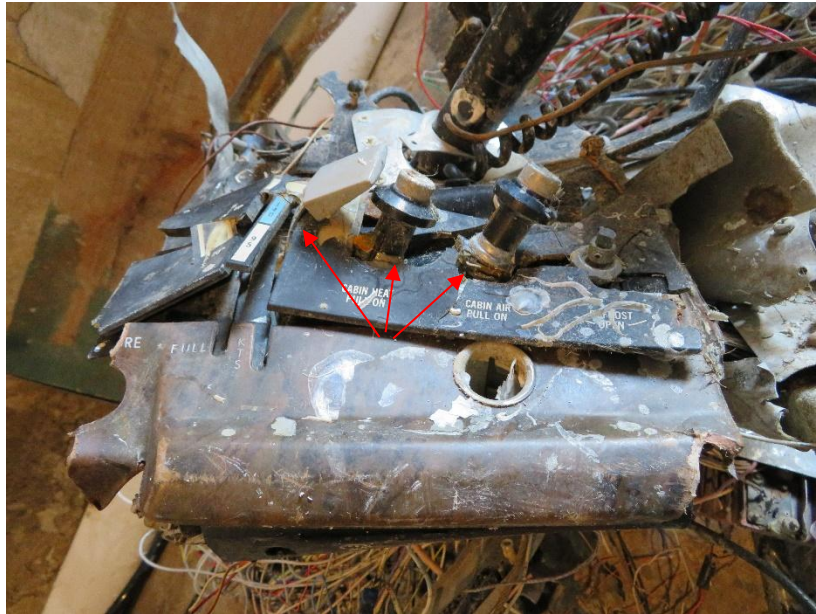
Photo 16: Right Instrument panel, the three switches right bending.

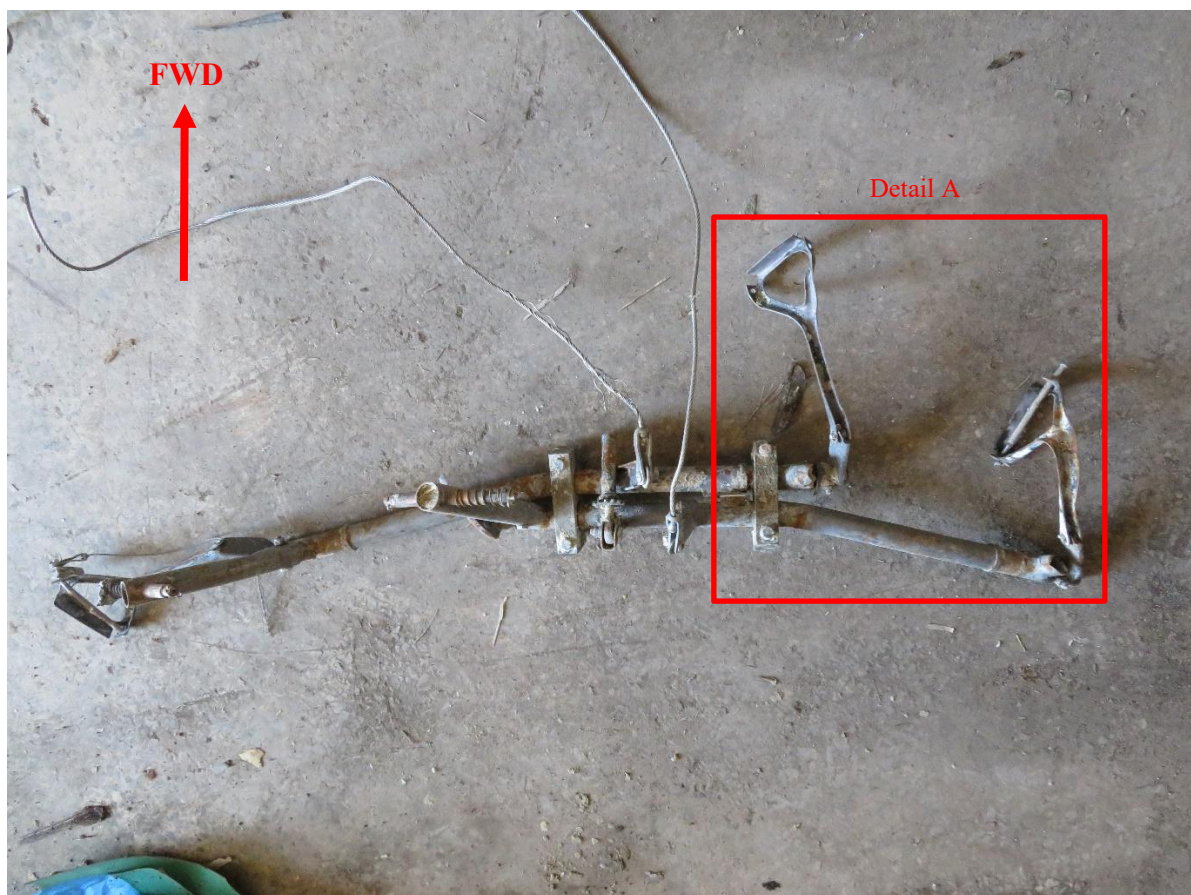
- The left and right rudder pedal bars were bent backwards, Anx. 5.11, Photo 17.
- In the left position, the rudder pedals are not fractured.
- The right seat rudder pedals are fractured. The fracture surface of the left rudder pedal is consistent with right bending, while for the right rudder pedal it is consistent with forward bending. Among the right position brake links, the left one had been twisted to the right, while the right one had been bent forward, Anx. 5.11, Photo 18.

Φωτ. 17: Left and Right Pedal Bars and Brake Links.

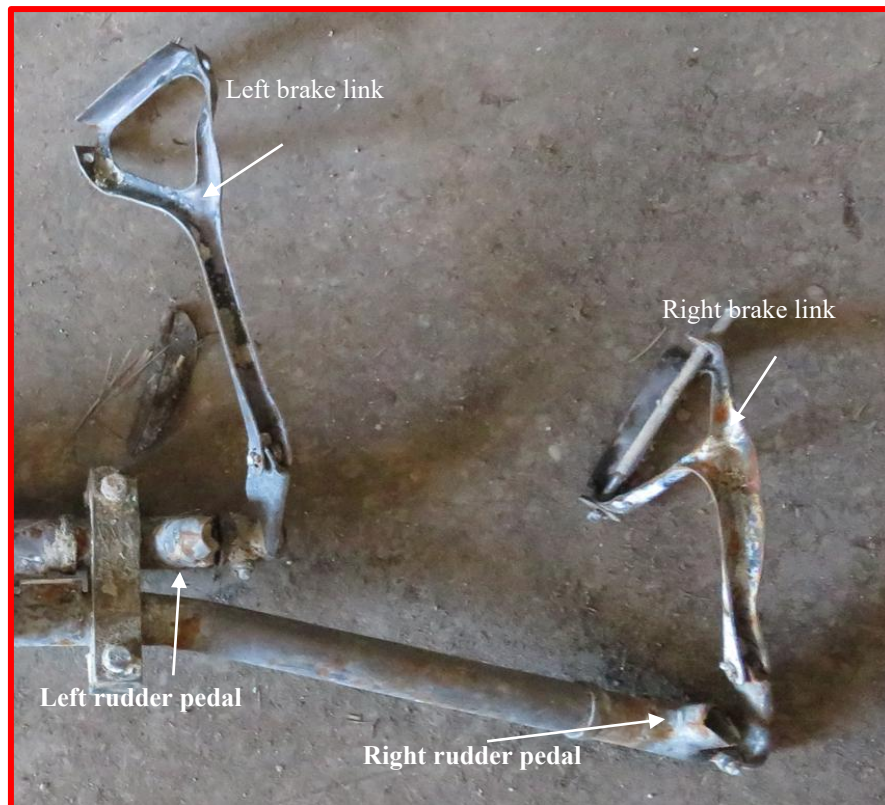
From the macroscopic examination of the fractures in the right-hand position rudder pedals and the deformation of the brake linkages in the same position, the deformation of the flaps lever, the cabin air and cabin heating levers and the forensic examination, it is concluded that the Captain occupied the cockpit right-hand position probably to have airport better view when performing the right-hand turns during the approach phase.

Photo 18: Detail A, right seat rudder pedal fractures.

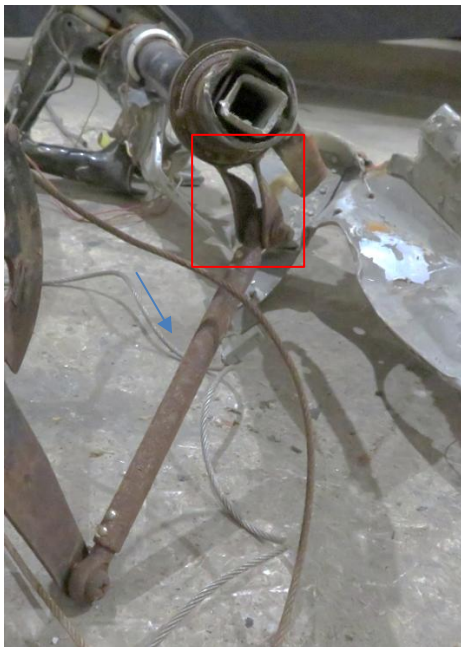
Photo 19: Left control column linkage

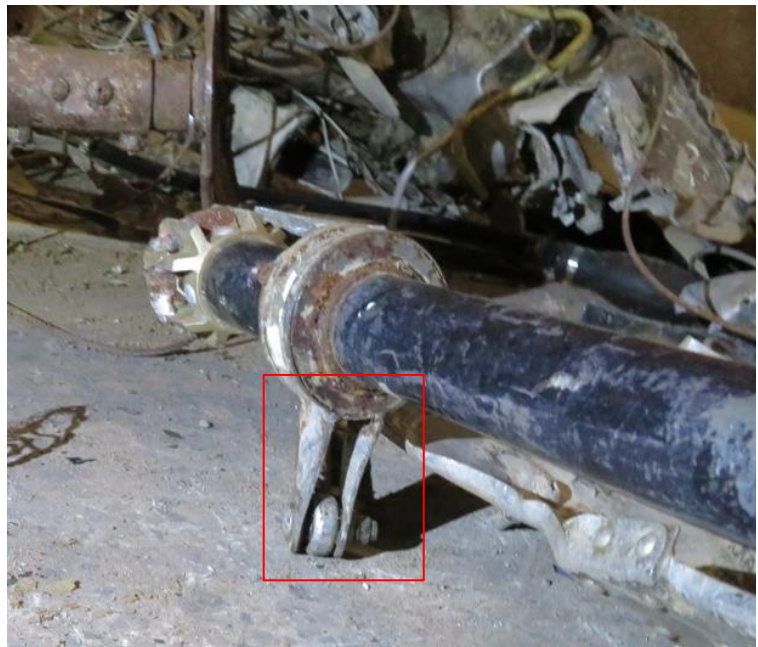
Photo 20: Right control column linkage

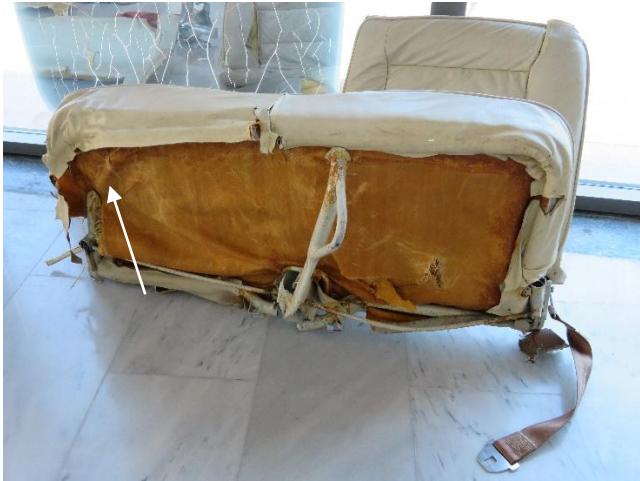
Photo 21: Rear seat frame showing the missing part of the right seat frame (white arrow).

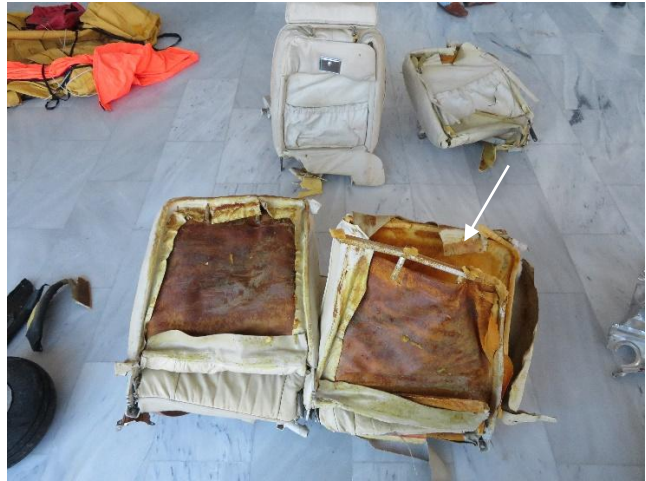
Photo 22: The frame of the rear seat back, where fracture and deformation of the right back frame the left can be seen.
