**HELLENIC AIR AND RAIL  
SAFETY INVESTIGATION AUTHORITY  
(HARSIA)**

**ACCIDENT INVESTIGATION REPORT  
OF AIRCRAFT I-6564  
IN CHARIA OF THE COUNTY OF ILIAS  
ON 21<sup>ST</sup> OF JUNE 2021**

**Accident of aircraft I-6564  
in Charia of the County of Ilias  
on 21<sup>st</sup> of June 2021**

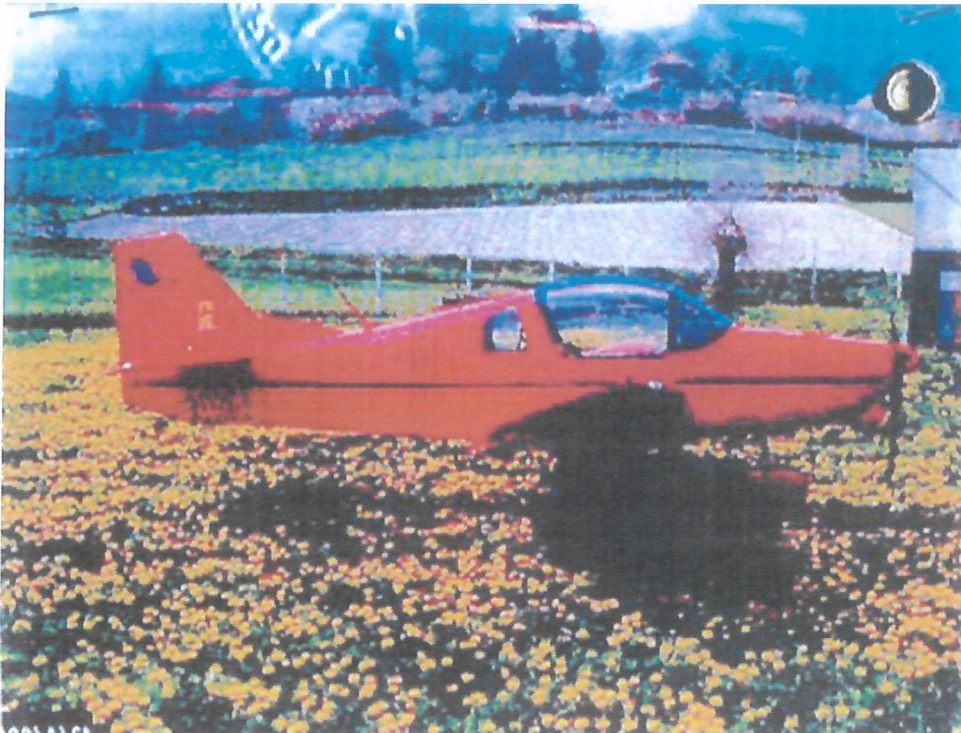
**Photo 1:** The MXP-640 AMIGOS S aircraft with registration I-6564

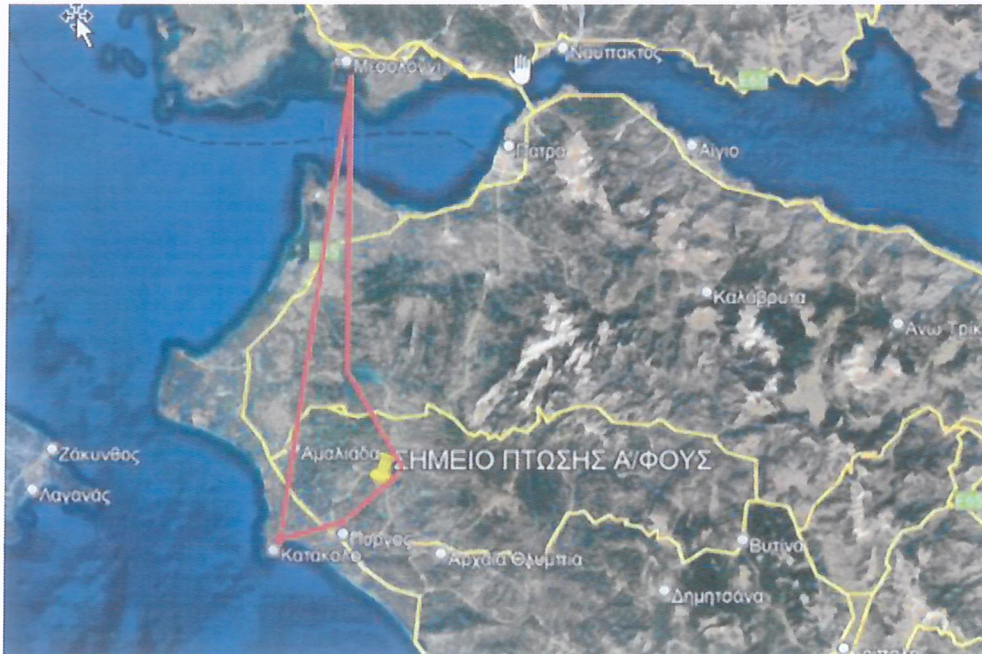
At 12:05 p.m., eyewitnesses reported that they saw the aircraft high banked and while the engine could be heard running, with a noise somewhat different from normal, the aircraft crashed uncontrollably into a house yard in the village of Charia, Ilias (**Photos 2 and 3**), with coordinates 37° 43.919'N, 21° 30.863'E and at an altitude of 137 ft.

**Photo 2:** Map with the aircraft's flight plan and crash site

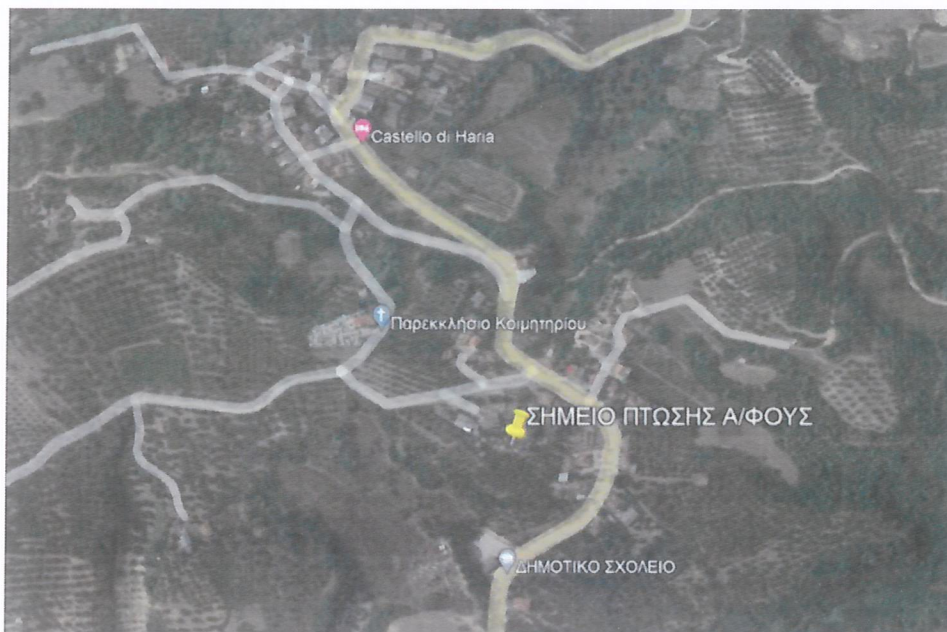
The village where the aircraft crashed is the home of the pilot and is located in a hilly area.

**Photo 3:** Crash site in the village of Charia, Ilias

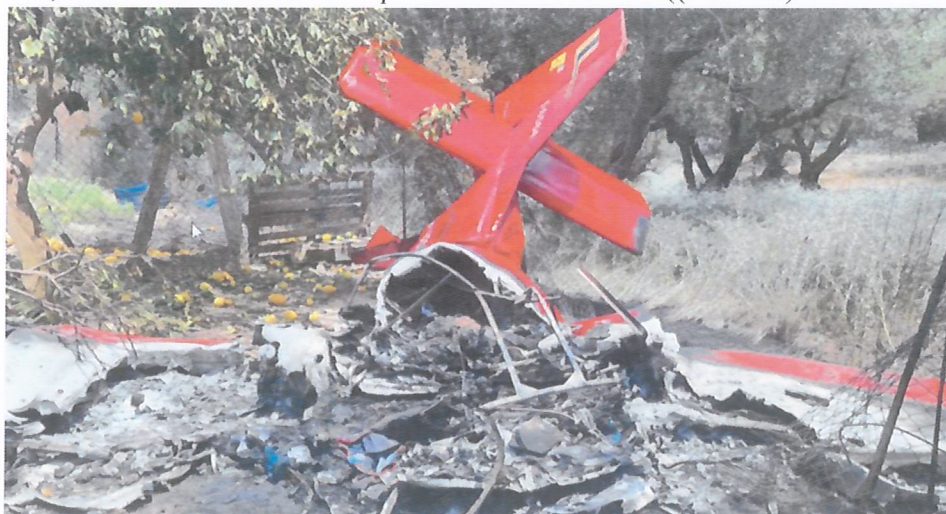
The aircraft was completely destroyed and, due to the fire caused by the fuel leak after its crash, was burned with the exception of its tail section.((Photo 4).

**Photo 4:** Debris of the aircraft at the crash site

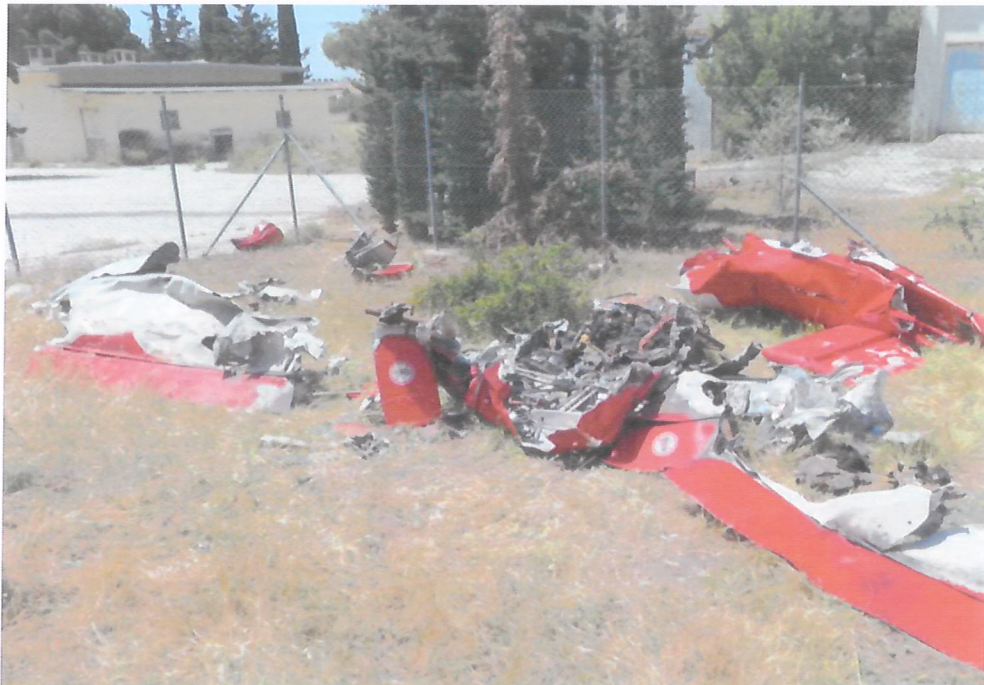
A check of the aircraft wreckage (**Photo 5**), revealed that:

**Photo 5:** Aircraft wreckage in the storage area (Dhekelia Airport)

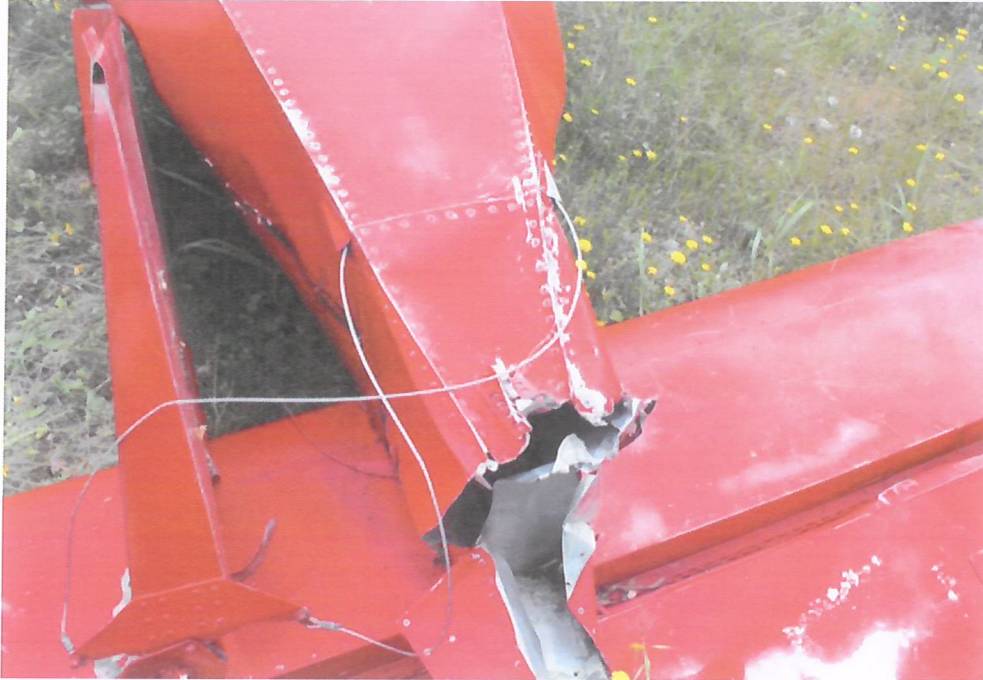
a) No discontinuity was observed in the connection of the rudder to the rudder pedals. The cables were found to be in good condition throughout their entire route, as were the end connections both at the height of the Rudder (**Photo 6**) and at the height of the Rudder Pedals (**Photo 7**).

**Photo 6:** End connections of the Rudder

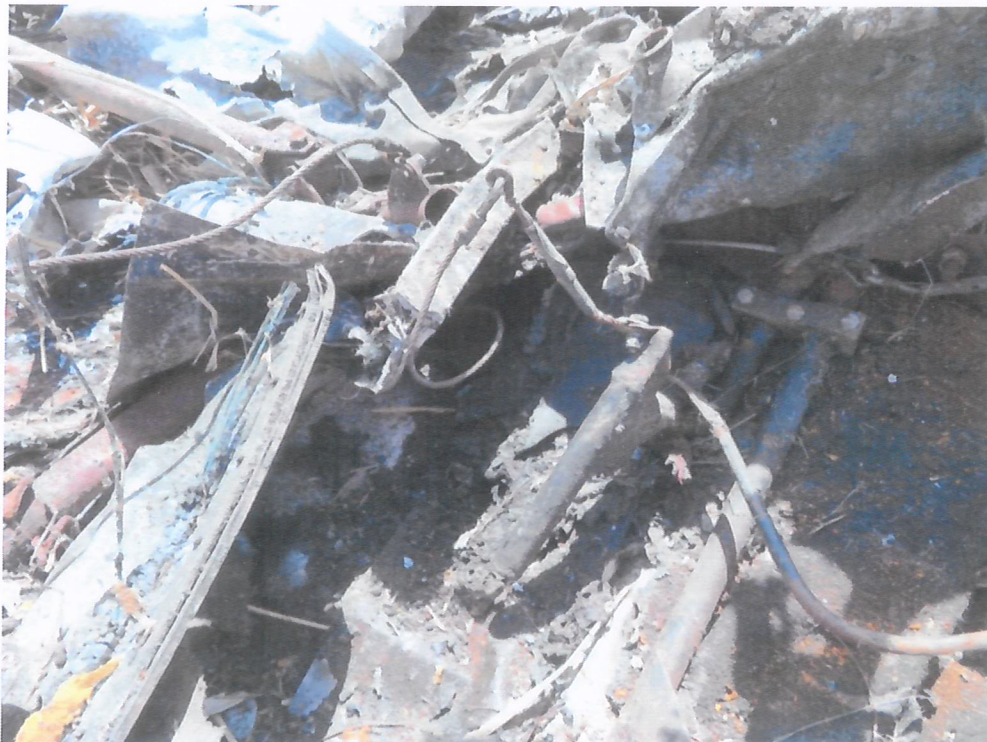
**Photo 7:** End connections of the Rudder Pedals

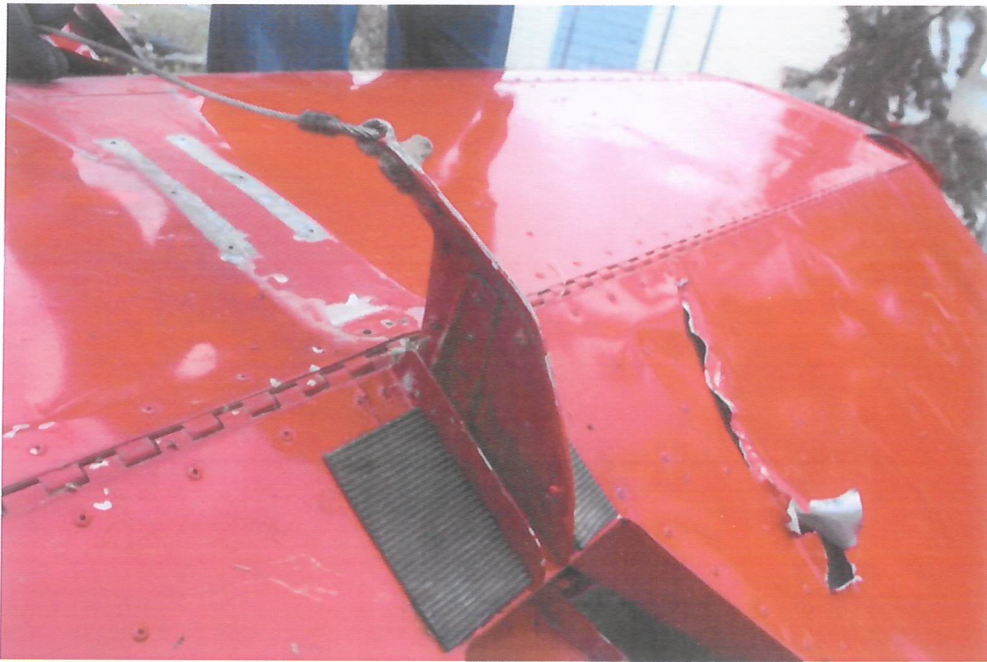
b) There was no problem with the connection of the elevator at the top of the elevator. The cable was found in good condition, as was its end connector. The bracket of the elevator that is connected to the end connector of the cable was found deformed due to the impact (**Photo 8**). The bracket at the bottom of the elevator that is connected to the end connector of the cable was found detached due to the impact. The rivet holes were found with cracks and deformed due to the loads they received after the deformation of the aircraft fuselage. The cable and its end connector were found in good condition (**Photos 9 and 10**).

**Photo 8:** Elevator end connection upper surface

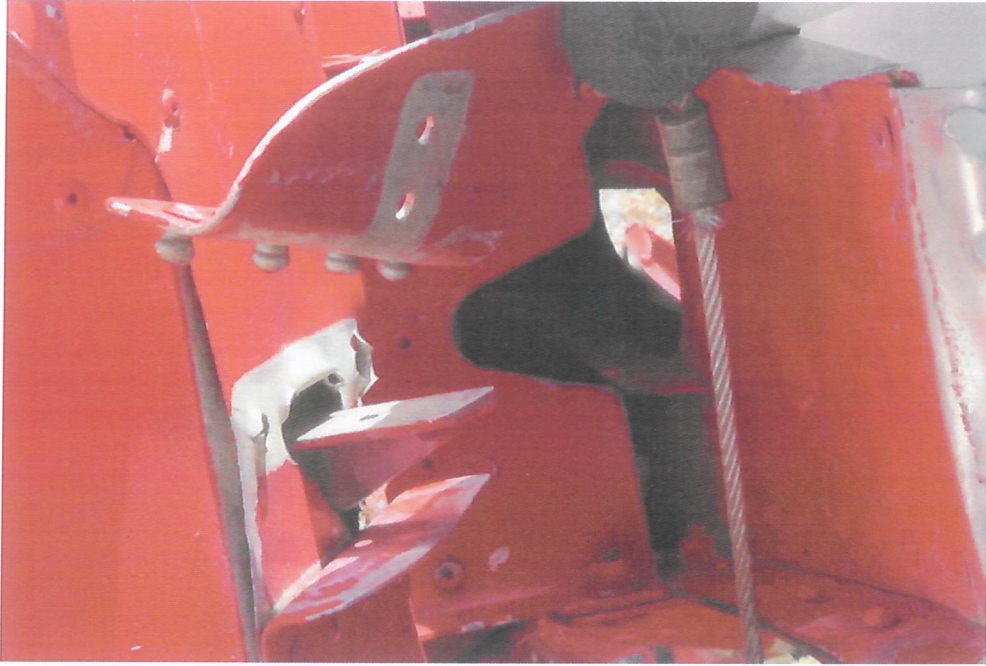
**Photo 9:** Detached elevator bracket lower surface

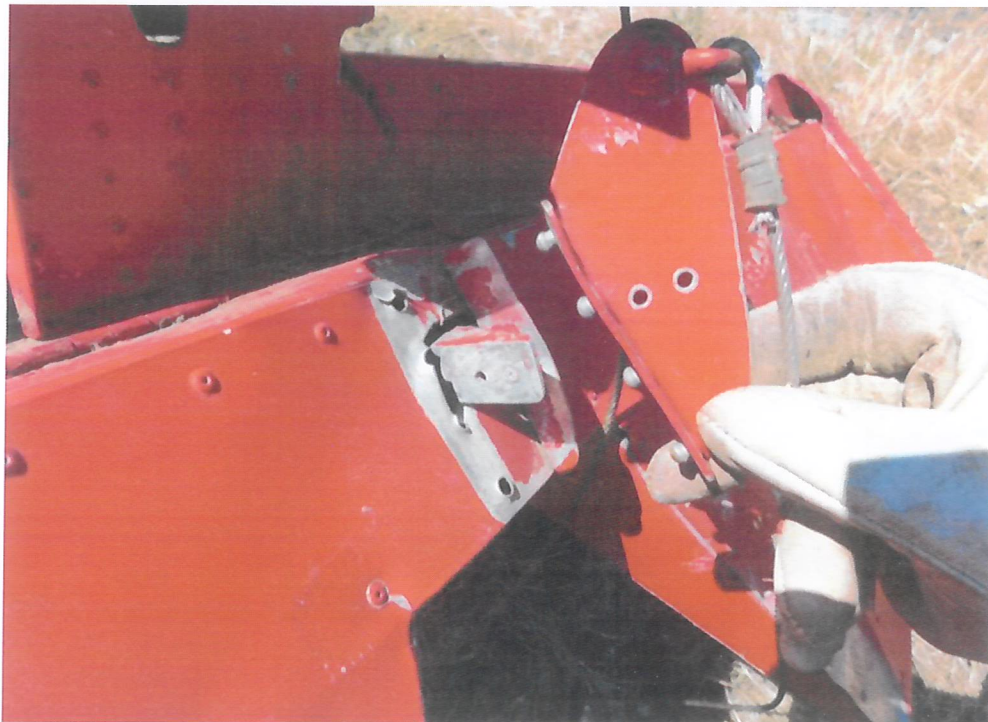
**Photo 10:** Elevator end connection lower surface

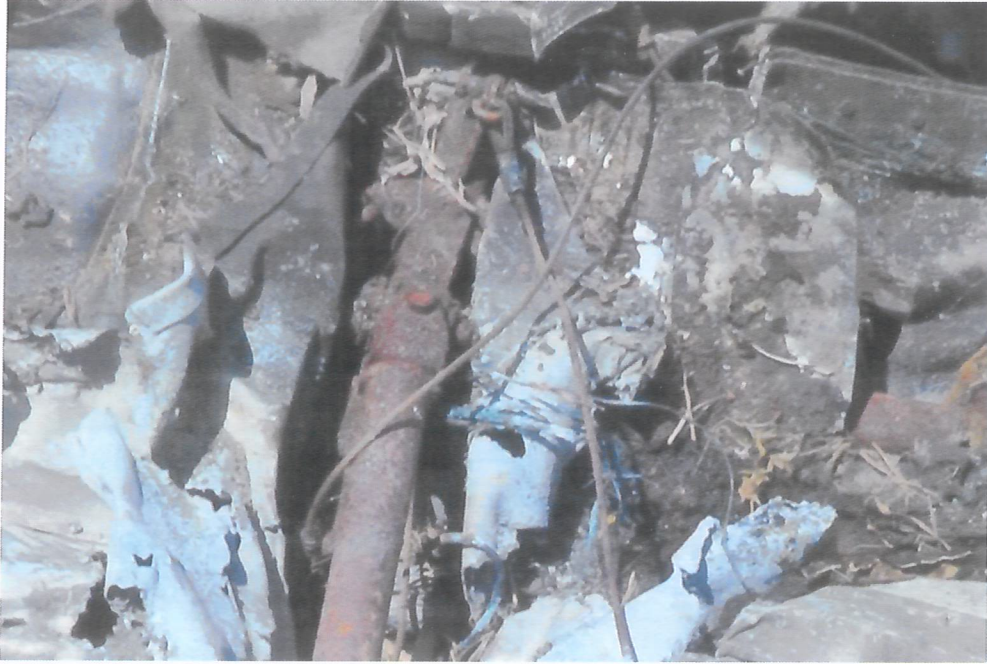
Also, no discontinuity was observed in the connection of the control stick to the elevator at the height of the control stick (**Photo 11**), where the cables and their end connections were found to be in good condition. Also, the elevator cables were found to be in good condition throughout their entire route.

**Photo 11** : Elevator end connections at the height of the control stick

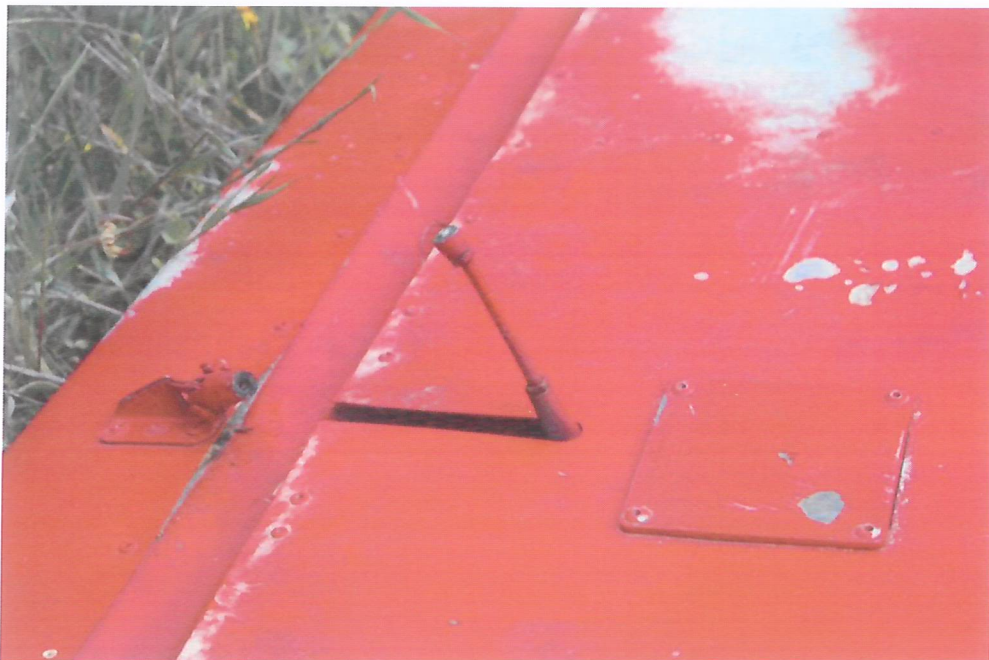
c) The trim tab LH Elevator (**Photo 12**) was found to be discontinuous at the height of the trim tab due to a fracture of the rod body, which also shows deformation. The fracture surface has characteristics of a static fracture due to impact. The bracket on the trim tab connected to the 'Rod Body' end connector was also found to be deformed due to the impact.

**Photo 12:** Trim Tab Elevator Connection

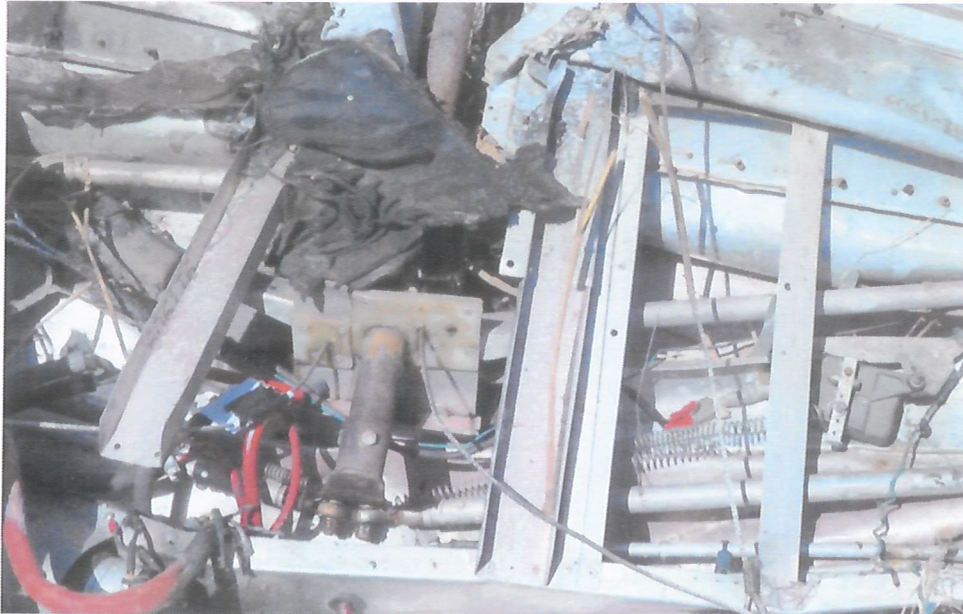
d) The connection of the longitudinal rod to the control stick and the transverse rods that transfer the movement from the control stick to the ailerons were found to be in good condition (**Photo 13**).

**Photo 13:** Connection of the Ailerons

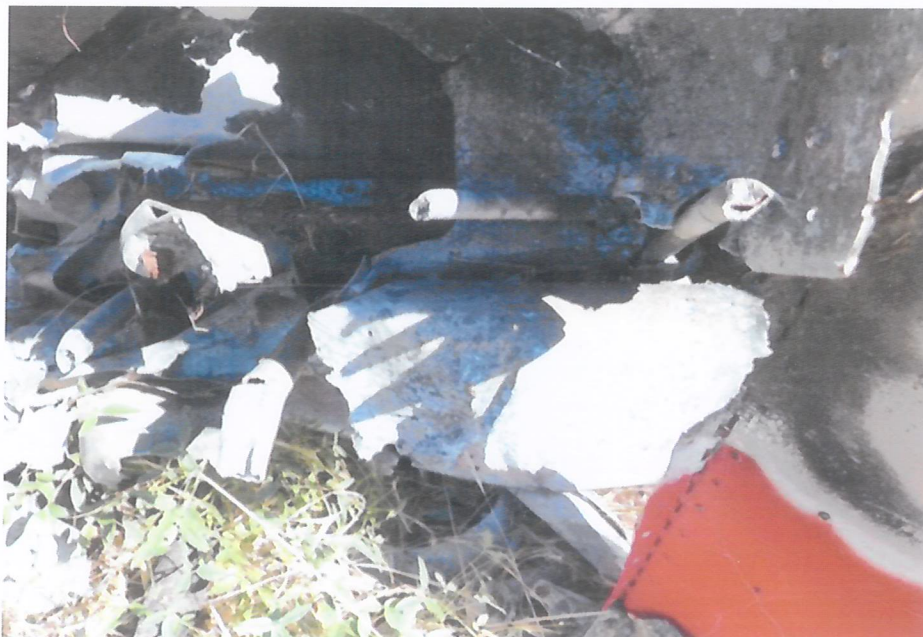
Discontinuity is observed in the connection of the left transverse rod with the left aileron at the height of the crank (Bellcrank), due to the impact and the fire that followed (**Photos 14, 15**). The connection of the arm that connects the 'Aileron' with the 'Bellcrank' was found in good condition on the left 'Aileron' (**Photo 15**).

**Photo 14:** Left Aileron and Flap transverse rods

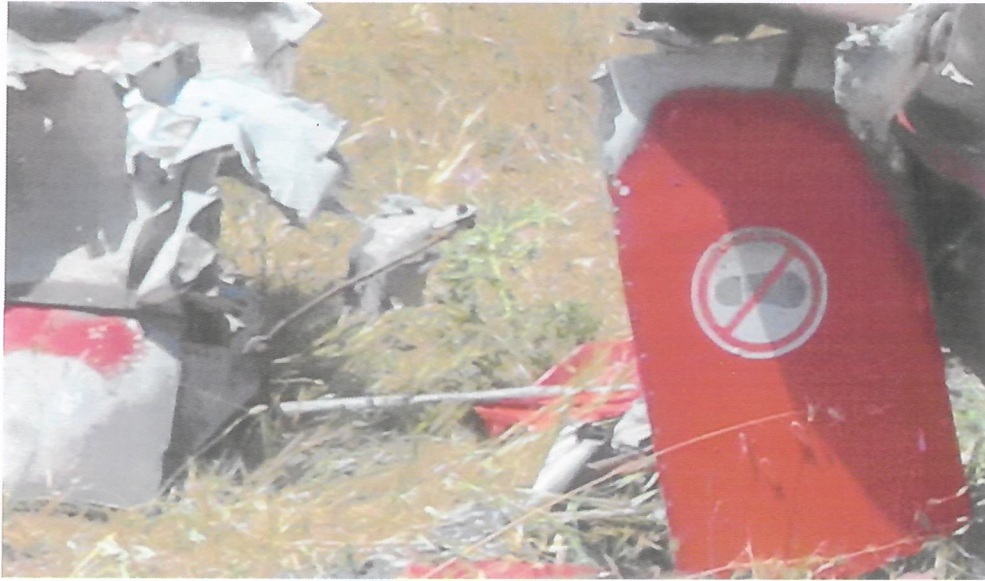
**Photo 15:** Left Aileron and Flap

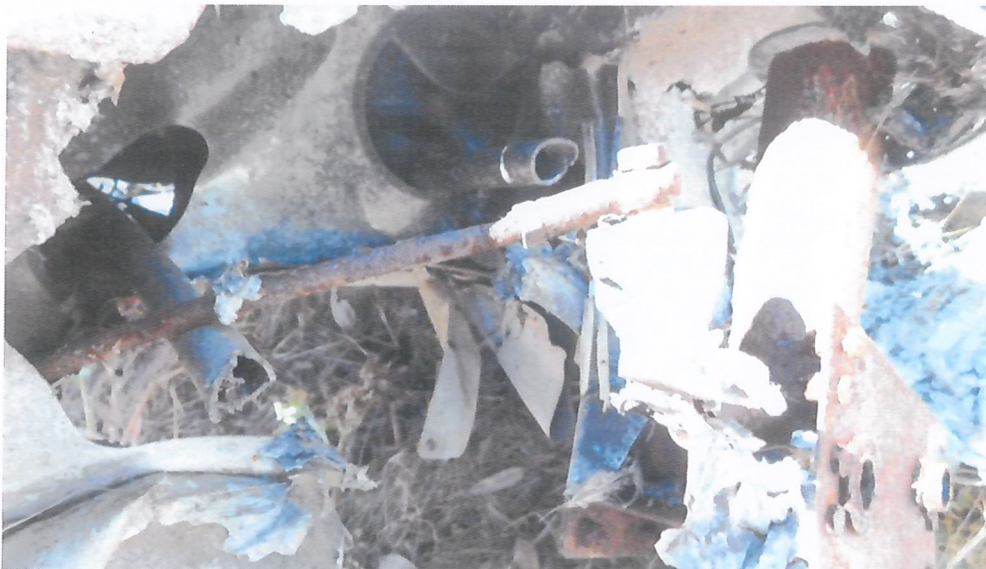
Discontinuity is also observed in the connection of the right transverse rod to the right aileron at the height of the bellcrank, due to the impact and the fire that followed (**Photos 16, 17**). The connection of the arm connecting the aileron to the bellcrank was found in good condition on the right aileron (**photo 17**).

**Photo 16:** Right aileron and flap transverse rods

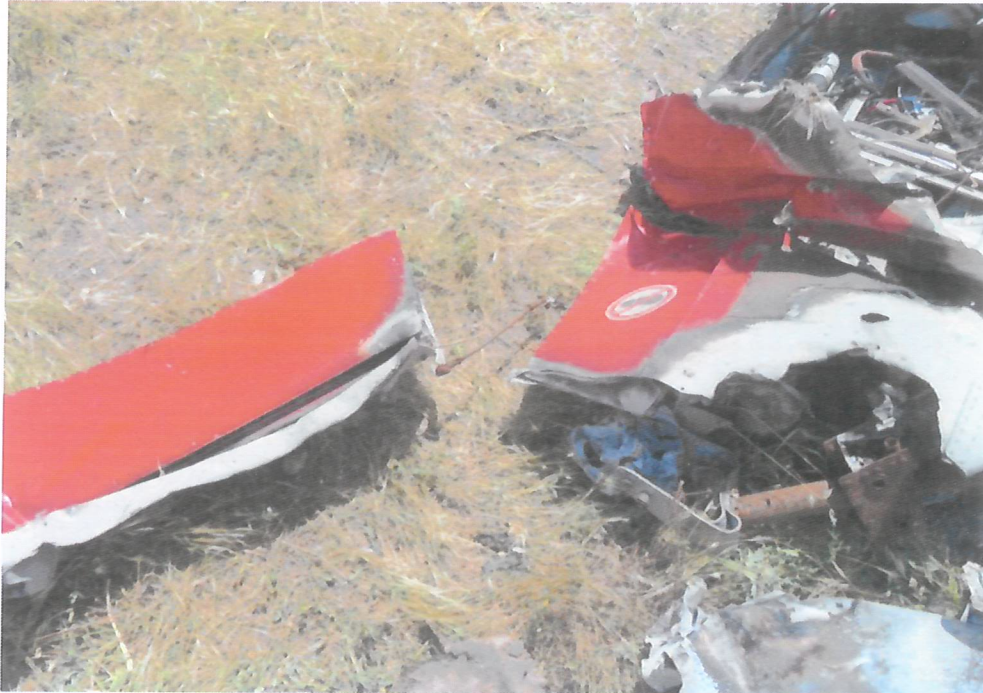
**Photo 17:** Right aileron and flap

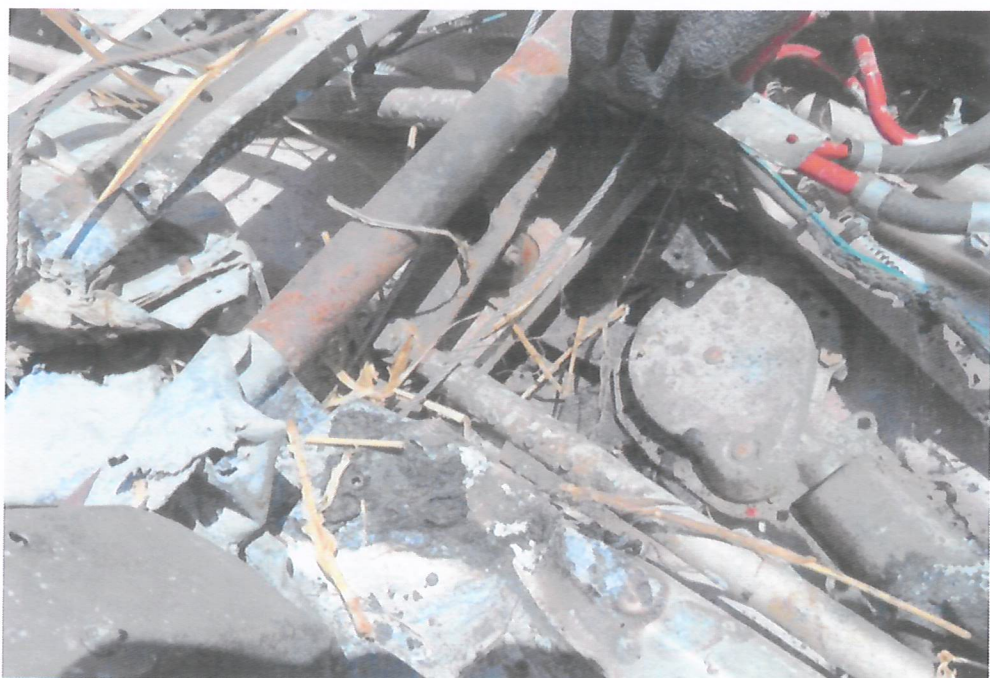
e) The transverse rods of the flaps and their connections at the height of the fuselage were found to be in good condition (**Photo 18**). Discontinuity is observed in the connection of the left transverse rod with the left flap at the height of the bellcrank, due to the impact and the fire that followed (**Photo 14**). The connection of the arm that connects the left flap to the bellcrank was found to be in good condition (**Photos 14, 19**).

**Photo 18:** The transverse rods connecting the flaps

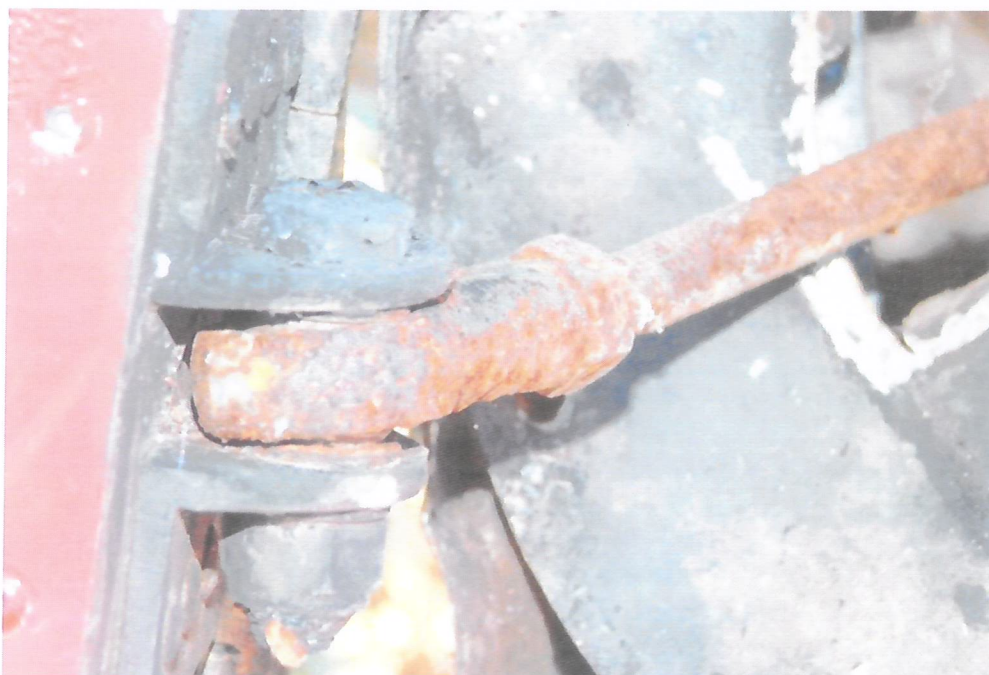
**Photo 19:** Arm connection with the left flap

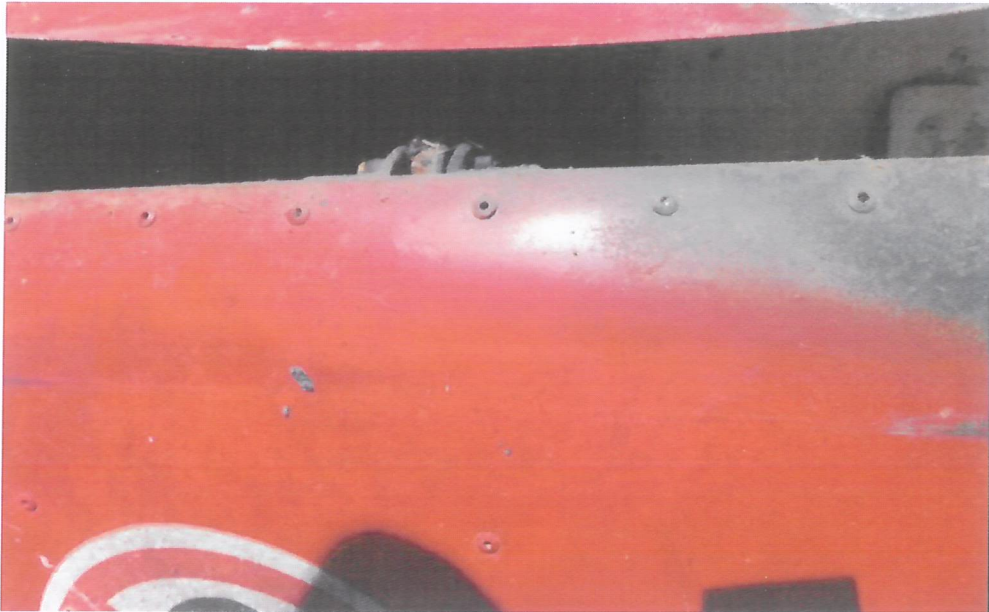
Discontinuity is observed in the connection of the right transverse rod with the right flap at the height of the bellcrank, due to the impact and the fire that followed (**Photo 16**). The connection of the arm that connects the right flap to the bellcrank was found to be in good condition (**Photos 16, 20**).

**Photo 20:** Arm connection with the right flap

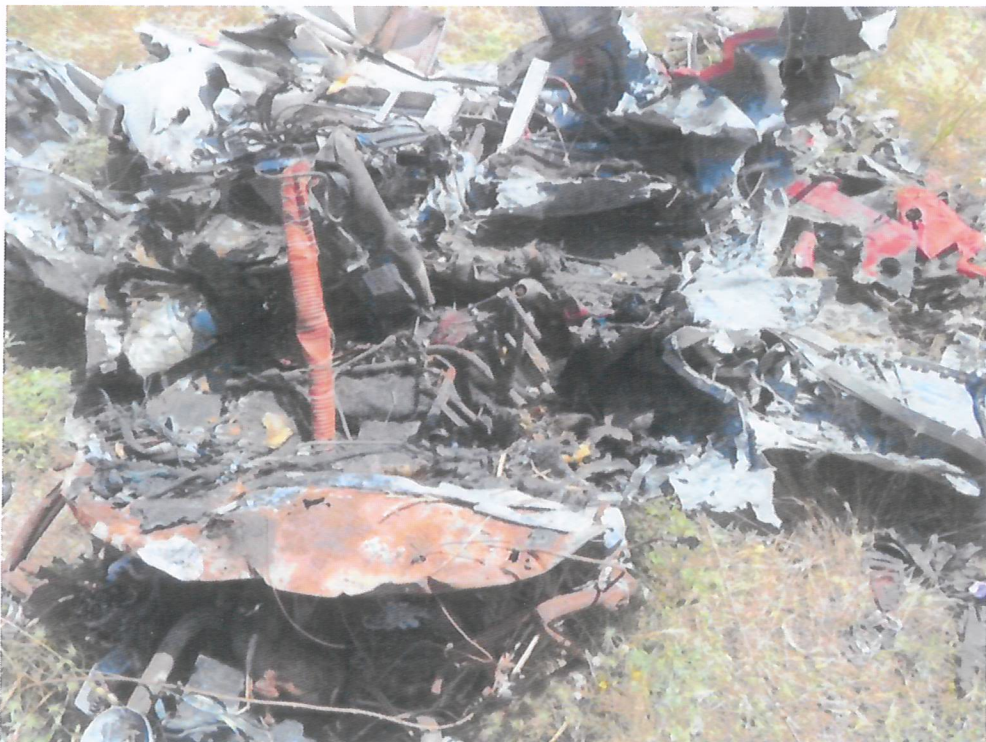
f) The front section of the aircraft's fuselage was completely burned, up to the height of the flaps, without anything related to the ballistic parachute being able to be identified (Photo 4, 21).

**Photo 21:** The burnt fuselage of the aircraft
