FINAL ACCIDENT INVESTIGATION REPORT

**ACCIDENT OF AIRCRAFT PILATUS PC-6/B2-H4 WITH REGISTRATION
NUMBER PK-SNF
IN THE SEA AREA OF KAKO OROS OF HERAKLION 2 NM EAST OF
HERAKLION INTERNATIONAL AIRPORT ON 15th DECEMBER 2022**

02 / 2025

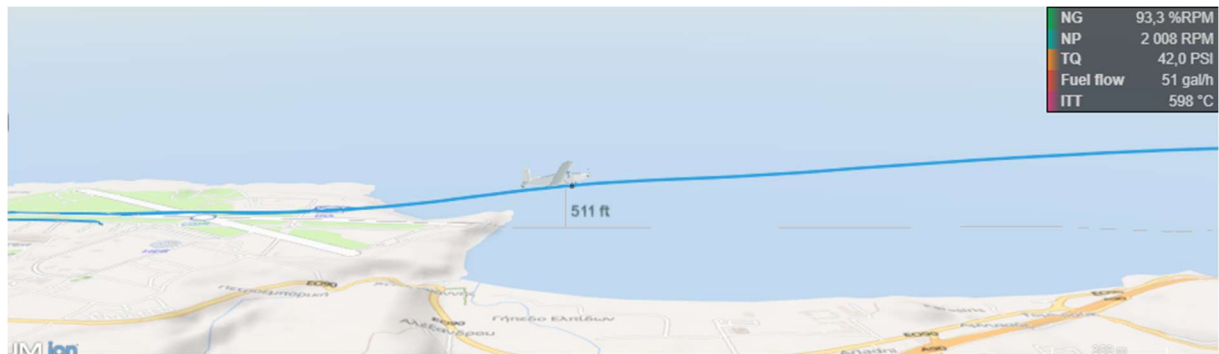
At 09:49:34 the aircraft was at a height of 511ft (Fig 2), the gas generator speed (NG) was 93.3% RPM, the propeller speed (NP) 2008RPM, the engine torque (TQ) 42 psi, the fuel flow (FF) 51gal/h and the intermediate turbine temperature (ITT) 598 °C.

Figure 2 : Characteristics of engine performance of the aircraft at a height of 511 ft.

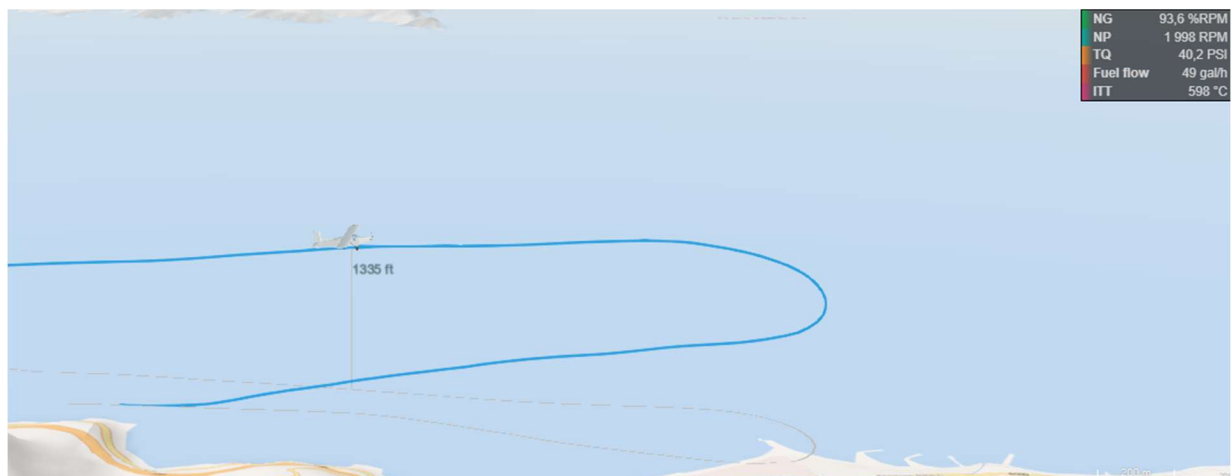
At 09:50:45 the aircraft was at a height of 1335ft (Fig. 3), gas generator speed (NG) was 93.6% RPM, propeller speed (NP) 1998 RPM, engine torque (TQ) 40.2 psi, fuel flow (FF) 49 gal/h and gas temperature between high-pressure and low-pressure turbine (ITT) 598 °C.

Figure 3 : Characteristics of engine performance of the aircraft at a height of 1335 ft.

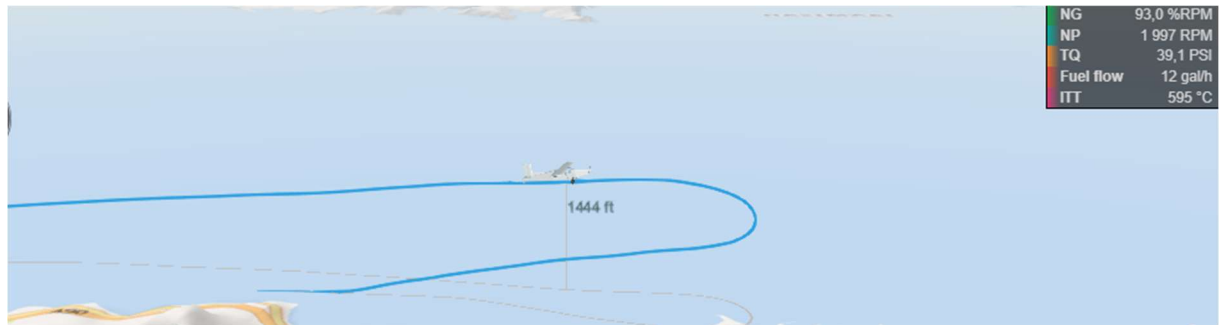
At 09:50:49, the Pilot apparently in his attempt to get the stuff he wanted, noticed that the rear right door of the cabin was partially open (according APIBOX System) then he unlocked the seat belt to close the door. His torso turned and stretched to try to close the door and almost immediately he felt that the aircraft was losing power. At 09:50:55 the aircraft was at a height of 1444 ft (Fig. 4), gas generator speed (NG) was 93.0% RPM, propeller speed (NP) 1997 RPM, engine torque (TQ) 39.1 psi, fuel flow (FF) 12 gal/h and inter turbine temperature (ITT) 595 °C.

Figure 4: Characteristics of engine performance of the aircraft at a height of 1444 ft.

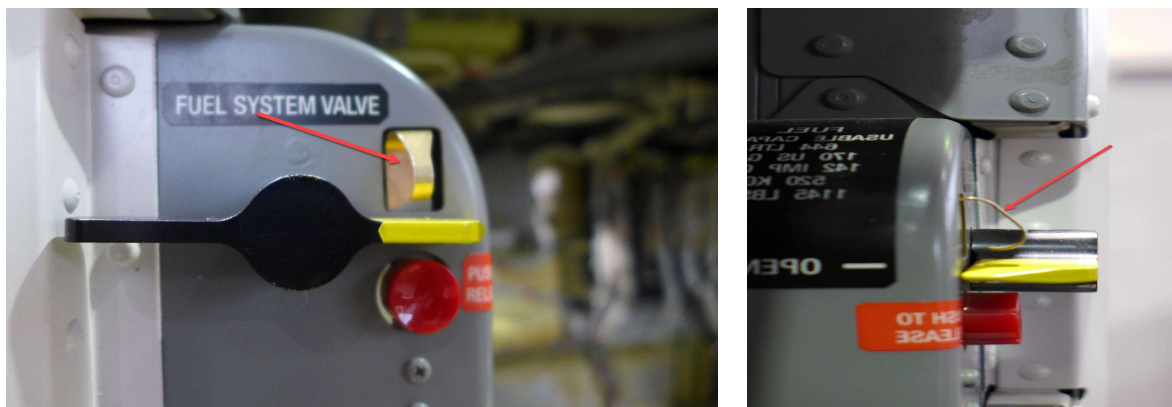
Figure 7 Fuel shut off valve Control lever

Initially, it was observed that it is possible to turn the fuel system valve upwards (in its closed position), without pressing the red button that isolates the lever locking mechanism. There was only a small resistance, as well as a small noise, without marks or deformation of the mechanism.

In a test carried out on the same type of aircraft to check the functional behavior of the fuel shut-off valve lever and to investigate the possibility of inadvertently placing the valve in a closed position, it was observed that it is possible to turn the fuel system valve upwards (in its closed position) without pressing the red button that isolates the lever locking mechanism. When moving the valve lever, there was a small resistance as well as a small noise without

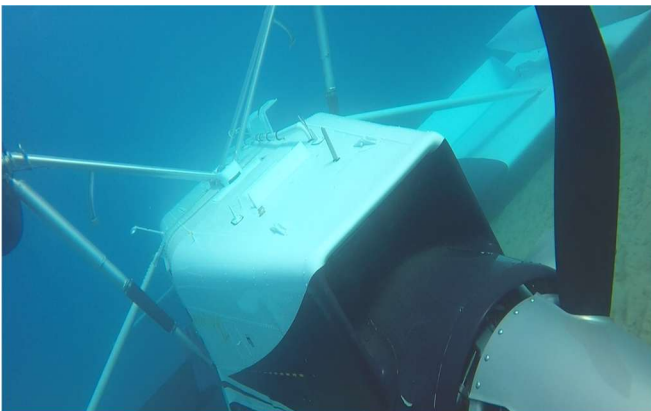
Figure 18 Detail from the front of the b/w

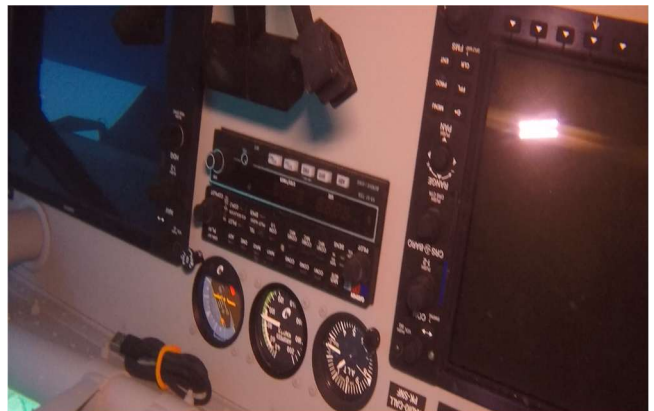
Figure 19 Detail from the dashboard

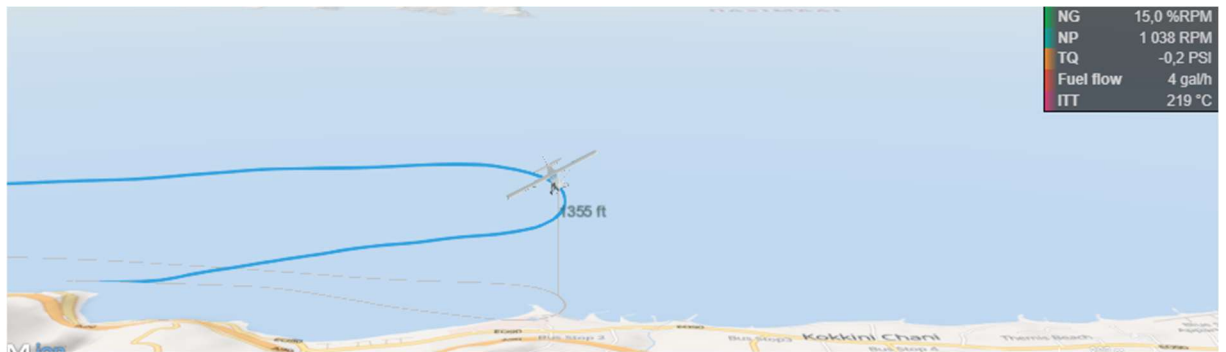
At 09:51:12h the aircraft was at a height of 1355 ft, the gas generator speed (NG) was 15.0 % RPM, the propeller speed (NP) 1038 RPM, the engine torque (TQ) -0.2 psi, the fuel flow (FF) 4 gal/h and the intermediate turbine temperature (ITT) 219 °C. The fuel flow to the engine had stopped.

Figure 28 The aircraft is located at a height of 1355 ft.

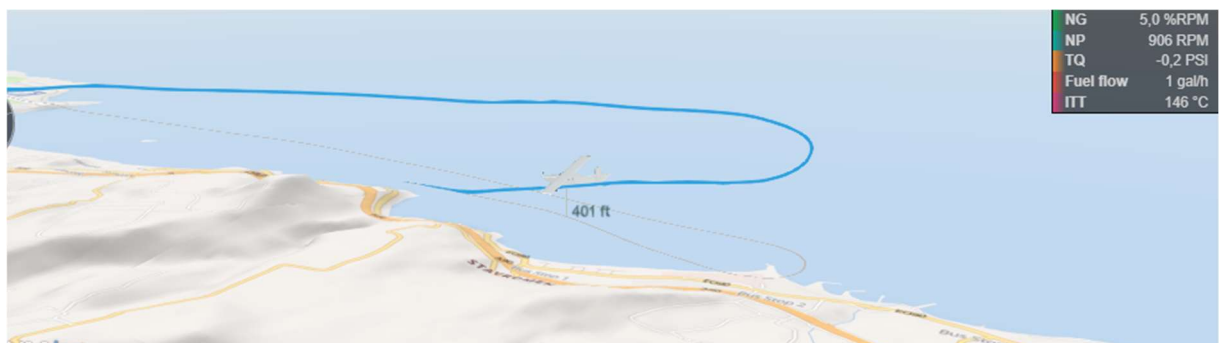
At 09:51:49h approximately 17 sec before ditching, the aircraft was at a height of 401 ft, the gas generator speed (NG) was 5.0 % RPM, the propeller speed (NP) 906 RPM, the engine torque (TQ) -0.2 psi, the fuel flow (FF) 1 gal/h and the intermediate turbine temperature (ITT) 146 °C.

Figure 29 The aircraft is at a height of 401 ft

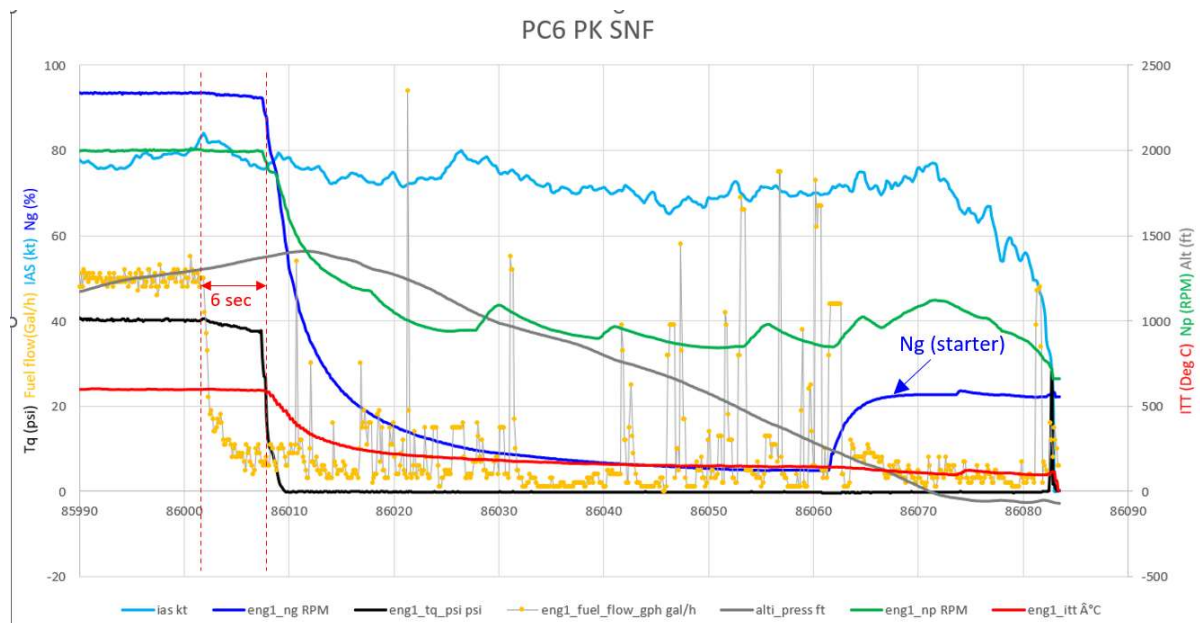
Graph 2 of Annex 5.2 shows some time-related aircraft and engine parameters taken from the APIBOX recording system from 07:50:41h to 07:52:15h inclusive.

Graph 2 Aircraft and engine parameters taken from the APIBOX recording system
