**HELLENIC AIR AND RAIL SAFETY
INVESTIGATION AUTHORITY
H.A.R.S.I.A**

**ACCIDENT INVESTIGATION REPORT
OF CESSNA R.182 AIRCRAFT WITH REGISTRATION MARKS
4X-CHZ IN THE SEA AREA OF PYTHAGORION, SAMOS**

ACCIDENT INVESTIGATION REPORT

**Cessna R.182 aircraft with registration marks 4X-CHZ on September 13, 2021 in
the Sea Area of Pythagorion Samos**

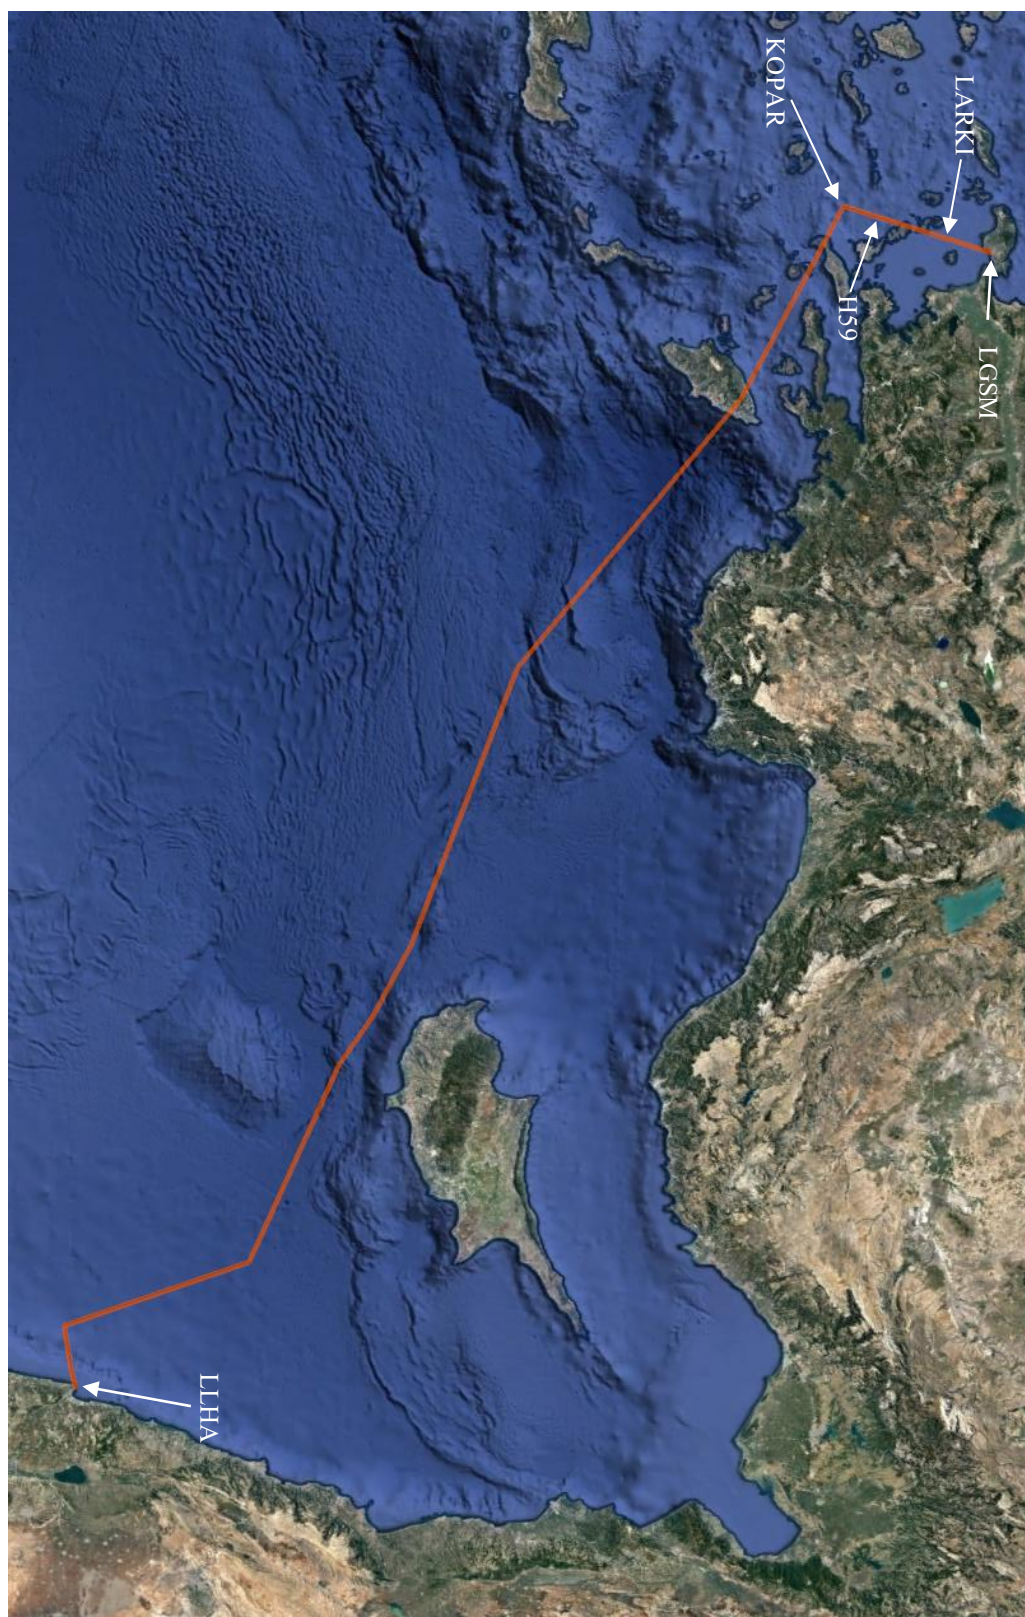
5.1 A/C flight track according to Flight Plan.

At 12:34 h a new flight plan to LGSM airport was submitted. According to it³, the flight was General Aviation with IFR rules, the scheduled departure was at 12:40 h on 2021-09-13 and its duration was 05:00 h. The flight path of the aircraft based on the flight plan is illustrated in Anx. 5.1, Fig. 2.

Picture 2: A/C flight track according to flight plan and the airports of departure and arrival.

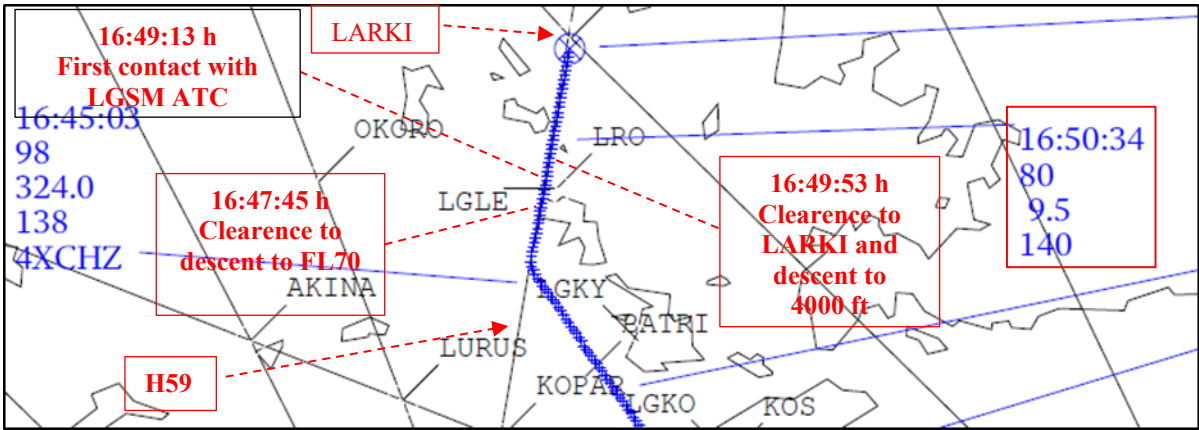
Fig.: 1: 4X-CHZ a/c track on airway H59 heading to LARKI point.

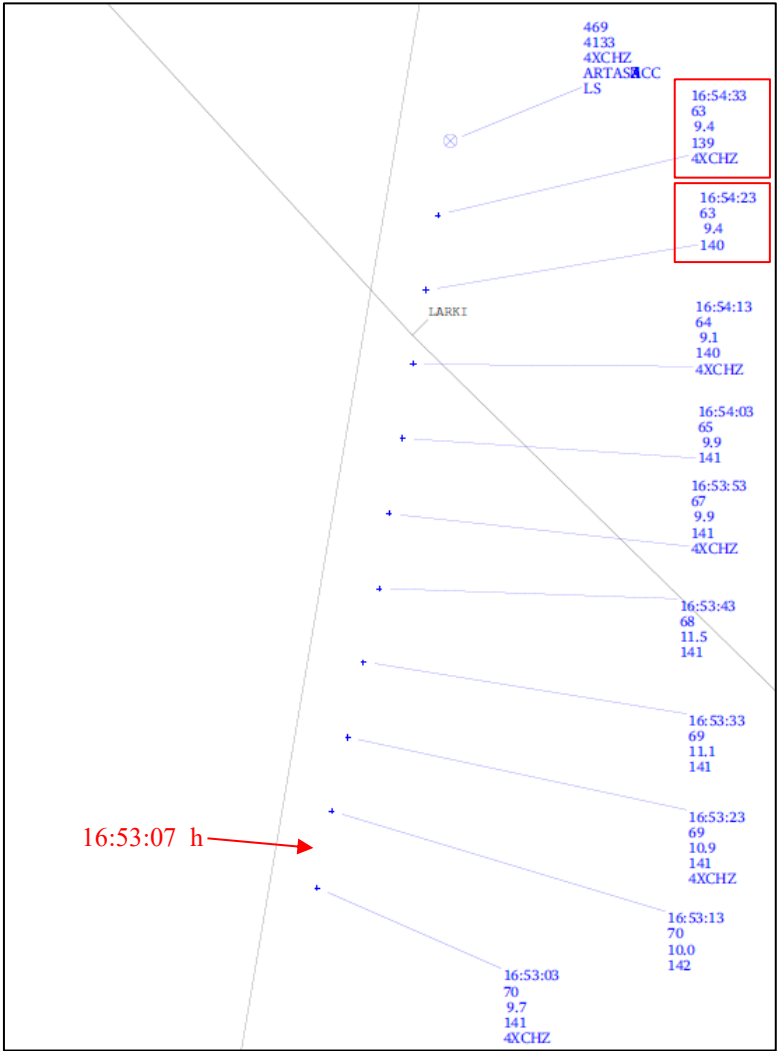
- The a/c was at LARKI point at 16:54:23 h, at FL 63 and ground speed 140 kt, Anx. 5.2, Fig.2.
- At 16:54:33 h was the last a/c recorded position, which was after the LARKI point at FL 63 with a ground speed of 139 kt, Anx. 5.2, Fig.2.
- After the last recorded position at 16:54:33 h until the time the a/c crashed on the sea, there was no recorded a/c position by the Radar system, since in this particular area the Radars cannot reveal a target at a low height due to shadows.

Fig.: 2: 4X-CHZ a/c track over LARKI point and its last Radar capture point.

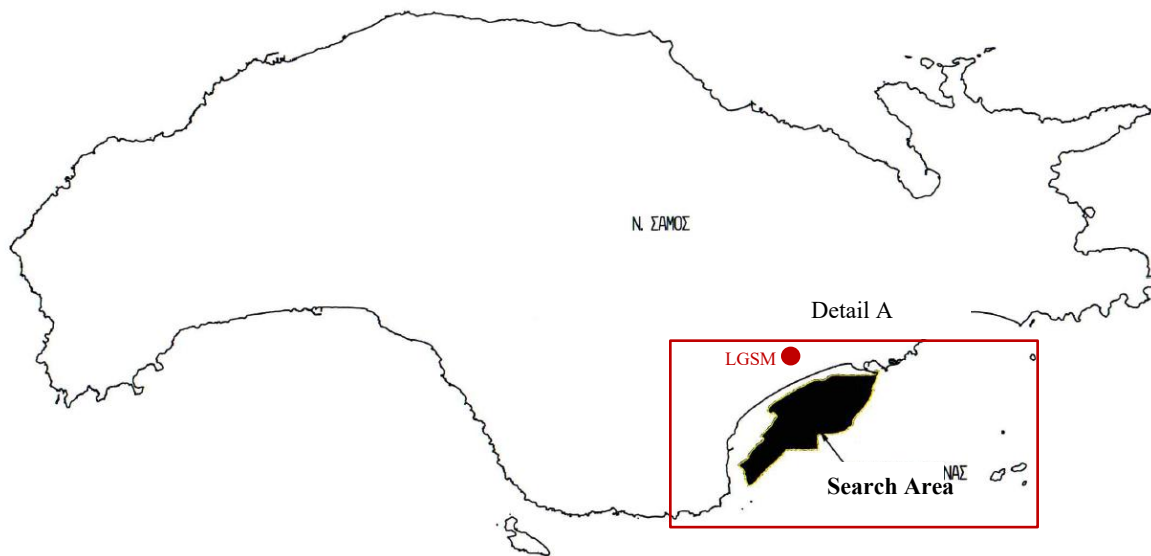
Picture 3: A/C discovery search area.

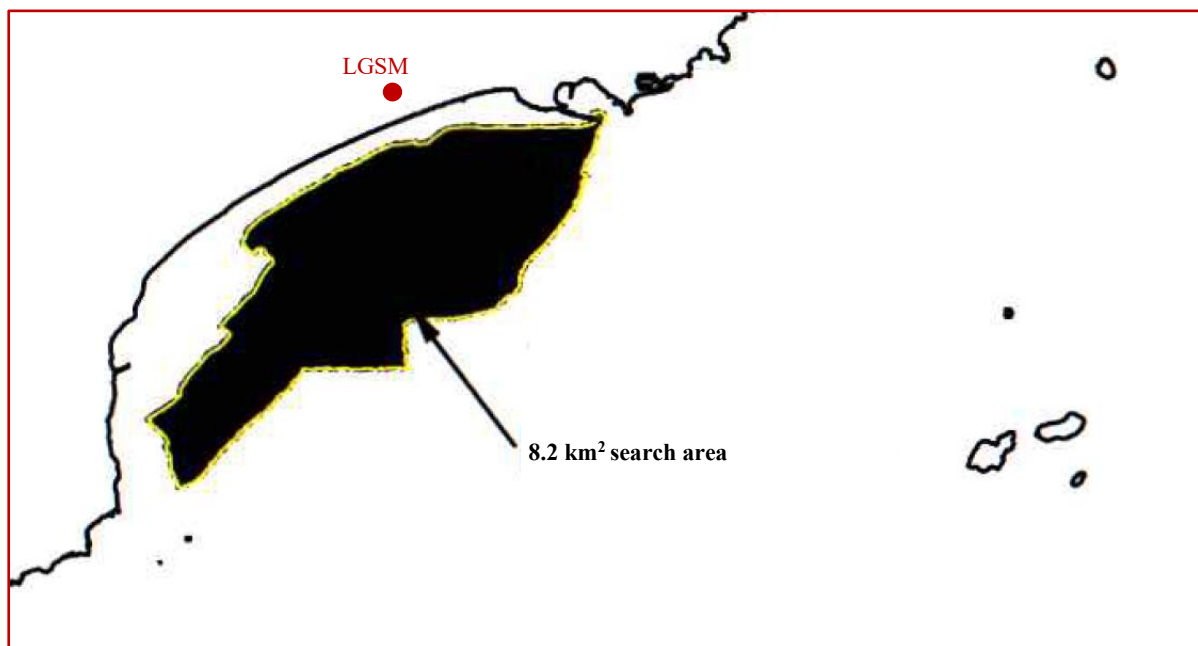
Picture 4: Detail A of search area.

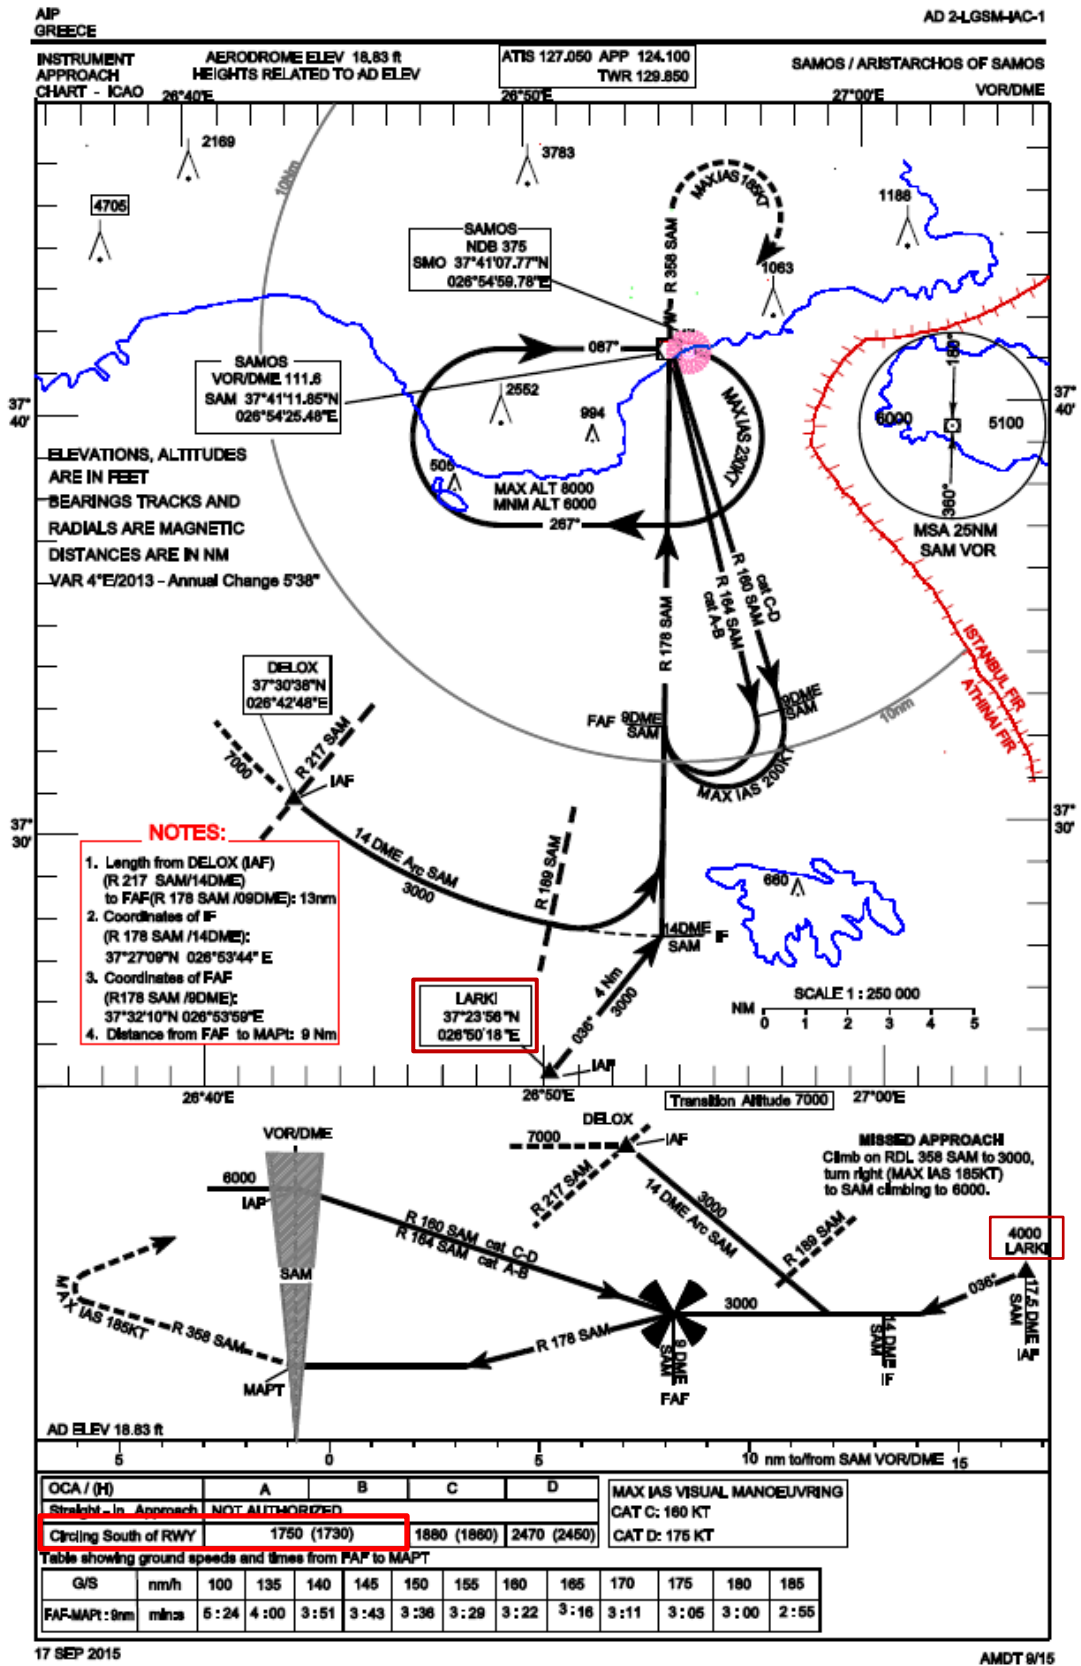
5.6 Samos Airport Instrument Approach Procedure

In Anx. 5.6, Fig. 5, the AIP-described VOR/DME instrument approach procedure to Samos Airport (LGSM) is illustrated, starting from the LARKI point with a minimum altitude of 4000 ft. It also mentions a “Circling South of RWY” approach with the Minimum Descent Altitude (MDA) after the FAF (Final Approach Fix), for the a/c category, 1750 ft while no authorization is given for a straight approach (Straight – in Approach: Not Authorized).

Picture 5: LGSM published VOR/DME approach procedure.
